OXFORDSHIRE BUILDINGS RECORD REPORT OBR.118

Farmyard Buildings Grange Farm, Balscote. OX15 6JN

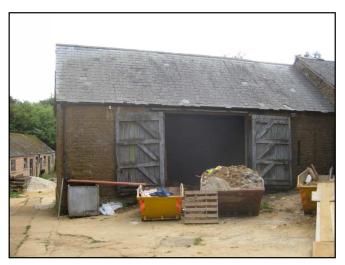
Figure 1 Barn, Grange Farm (D. Clark)

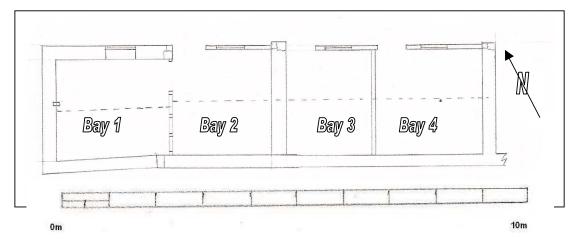
Figure 13 Cattle range, ground plan

Building 2 (Fig.11) is a 4-bay single storey range of stone and concrete block construction with a gabled corrugated asbestos roof over clad with corrugated iron and a partly boarded

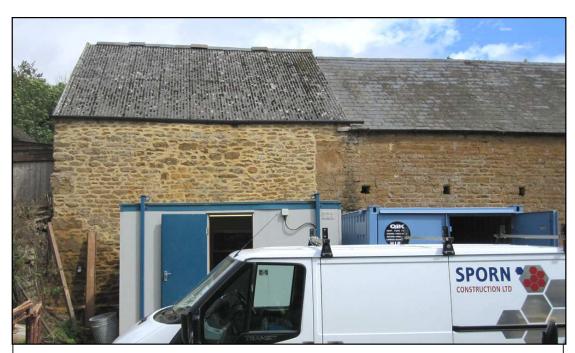
Figure 19 South west elevation. Builder's sheds prevented close inspection of this section of the building

The junction between the ranges (fig. 19) is marked by a vertical straight joint. This is overbuilt by range 1 roof and the top part of the same range's wall. This may be where the eaves of range 1 have been raised and its roof extended although new pointing on just range 1 wall may be confusing the evidence.

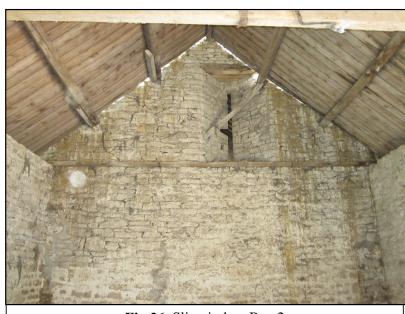
In the gable (Fig. 26) a ventilation slit has a splay opening to this side (i.e. into range 2). The ventilation slit is offset to the north and centred on range 1 rather than range 2. The roof structure sits awkwardly across the splay. The roof is supported against the gable wall rather than on it as is more conventional. A waney tie beam sits against the gable and probably connects the wall plates. An angled brace across the splay supports one of the purlins. This maybe

Fig 26. Slit window Bay 2

a later addition due to the purlins rotting where they enter the wall. Other purlins appear also to have supports added. The internal wall is stained from water penetration between the roof and the gable.

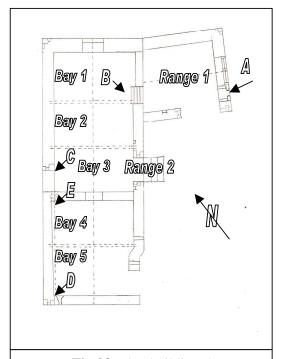
Fig 28. Plan building 5
