## OXFORDSHIRE BUILDINGS RECORD REPORT OBR.37

### Manor Farm Southside Steeple Aston

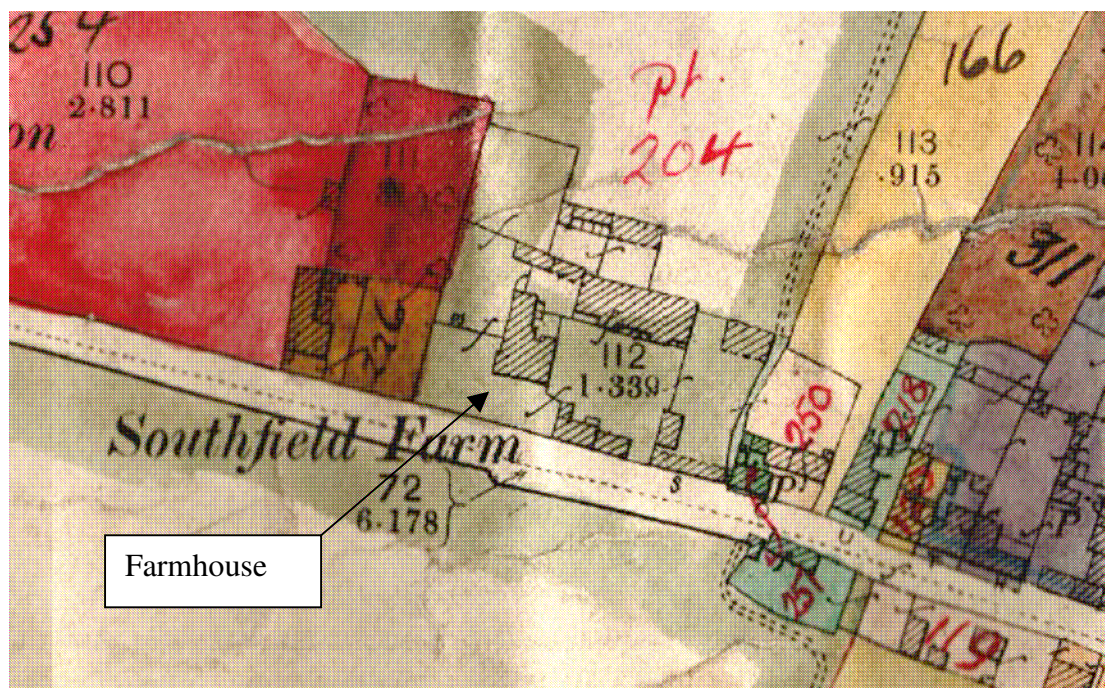
Manor Farmhouse sits on a sloping plot on the north of the road called Southside in the village of Steeple Aston. It is set back from the road and was once known as Southfield Farm (plot 204 on the 1910 DV map at Fig.2 below).

**Figure 2 Extract from 1910 DV map (Oxfordshire County Council – Oxfordshire History Centre)<sup>1</sup>**

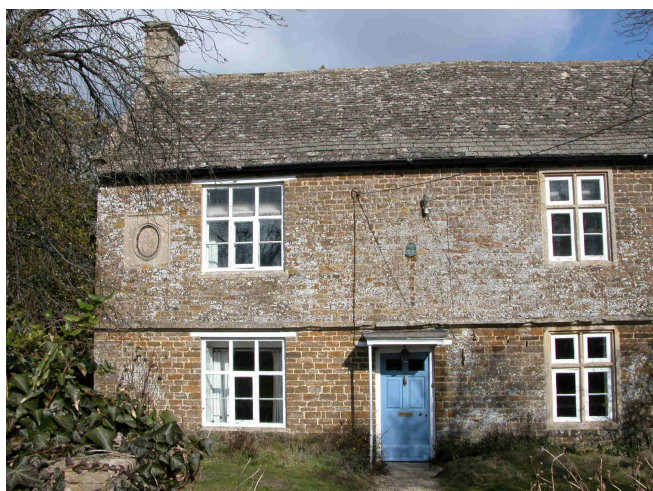
**Figure 3 Manor Farm south elevation, left hand side**

When we recorded the building, we felt that the façade was early 18<sup>th</sup> century in date (Fig.3); a degree of symmetry deriving from a pair of elliptical panels (Fig.4) – which we thought had formerly been windows – to each side of the first floor. However, both the list description and the Buildings of England would push the date back into the late 17<sup>th</sup> century.<sup>2</sup> However, there are features that point to this being a refronting of an earlier house. The doorway is off-centre to the left, and the fenestration either side is quite different. To the left there are two wide casements with timber lintels through which the floors of the rooms within can be clearly seen. On the right, tall rooms are lit by four cross-windows. The whole is linked by a string-course – in effect a drip-mould with a lip and cyma-recta moulding below – which returns to the right gable (but not to the left).

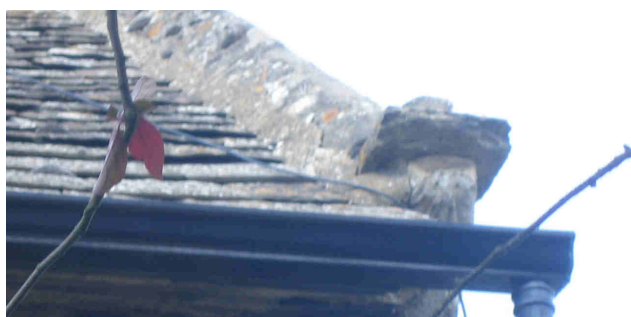
**Figure 5 Coping and kneeler to east**

At either end of the roof are ashlar stacks, one flue to the left, and two at an angle to the right. The roof is of Cotswold stone slates to the front (with some artificial replacements), plain red tiles to the rear. The kneelers to the gable copings appear to have had carved ends (Fig.5).

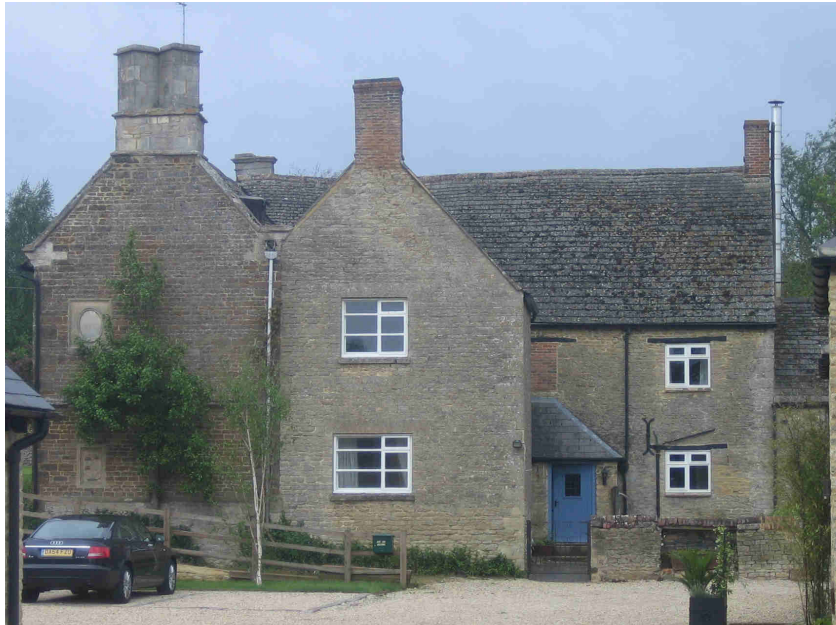
**Figure 6 East elevation**

To the east (Fig.6) the structure can be seen to consist of two distinct ranges parallel to the road with a long wing at right angles to the rear. In the re-entrant is a porch, and

at the north end is a two-storey extension, probably erected as a granary with poultry house below. There are openings for pigeons in the north gable (Fig.7).

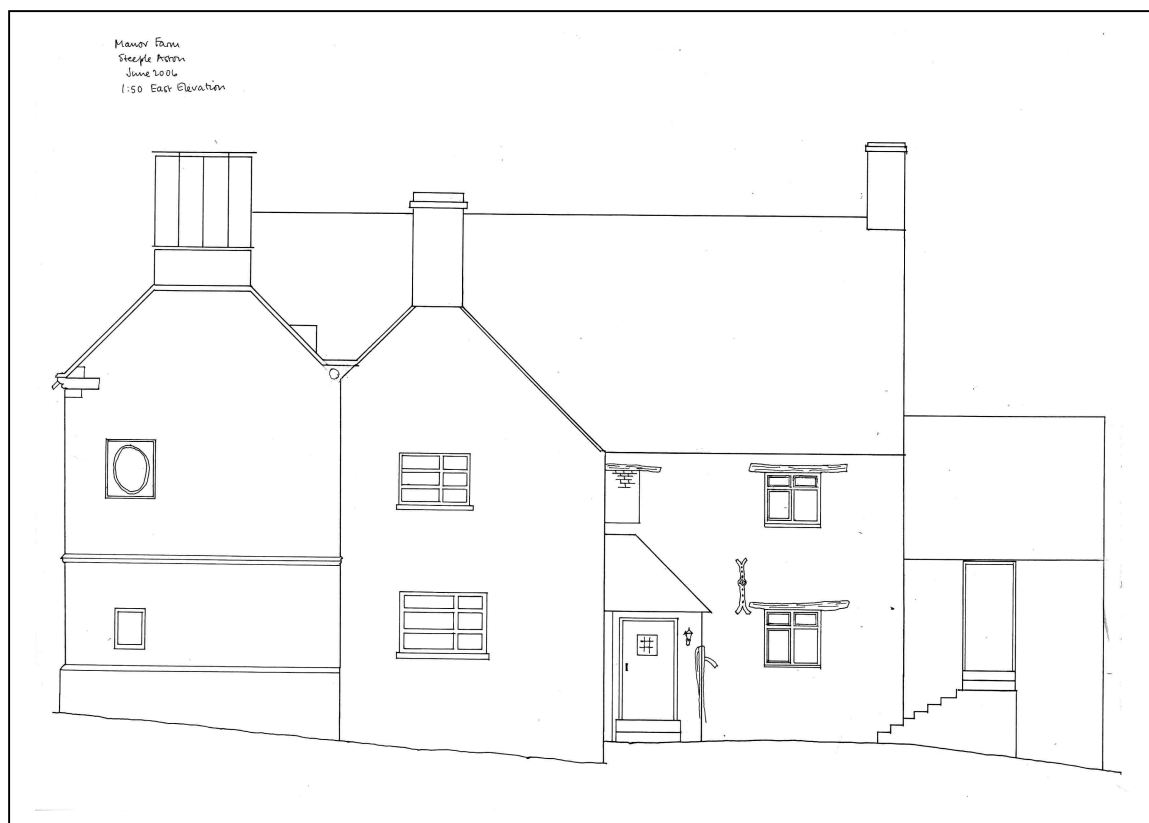
**Figure 8 East elevation (incomplete)**

Some of the features of the east elevation are shown in the drawing below (Fig.8). In the street range is a further blocked elliptical window to the first floor, and a rectangular one below to the ground floor. There is also a small window to the basement. The next range has modern windows and a brick stack. In the rear range one of the windows has been blocked in with brick. There is a pump outside the rear porch doorway.

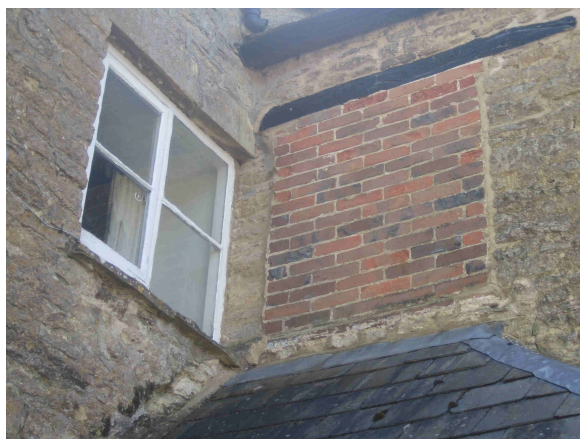
**Figure 10 Blocked window at join of C and D**

Apart from the porch and the granary building, the most recent structure is the range marked D, as it is butted up against the rear wall of the front range B, and partially obscures the blocked window at first floor level in C (Fig.10). However, the blocked mullion window to the cellar appears to be in situ and suggests that D was built over a pre-existing cellar. As the staircase is within D, there must have been another way up to the first floor before this was built.

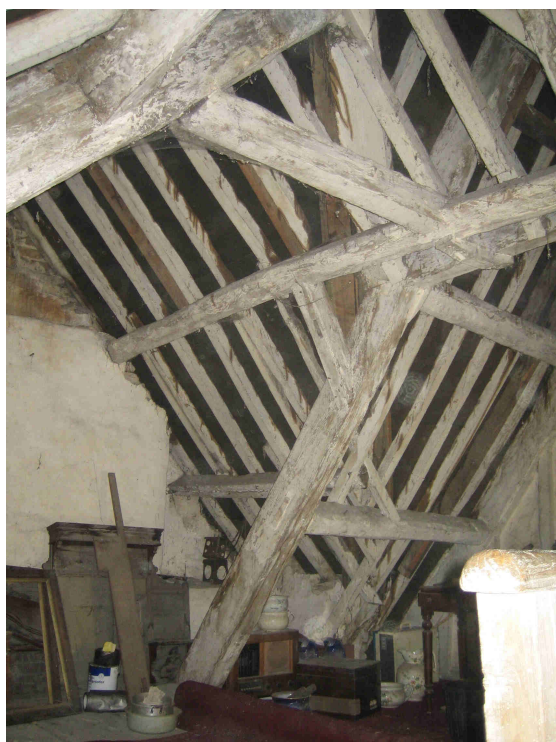
The roof (Fig.11) gives the clue for the front range. Range C dictated the floor levels in A, but in B the ceilings are higher and unconstrained by another building.

**Figure 11** To the left is the west gable of the front range. In the centre one of the trusses of the rear wing extends into the roof of the front range.

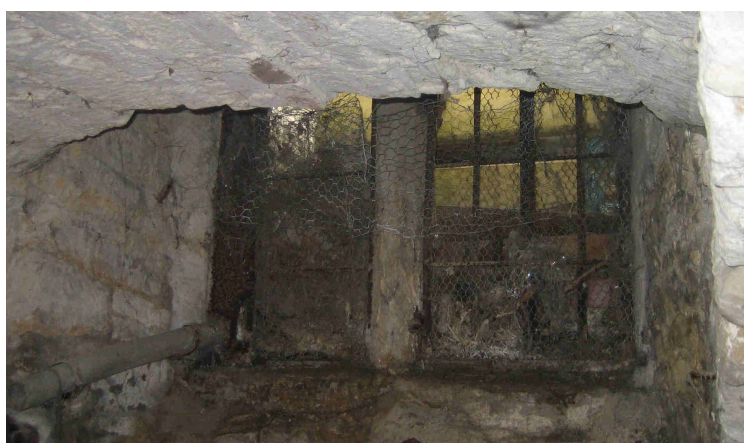
As for putting dates to the phases, the stone mullion window to the cellar has plain chamfers (Fig. 12), and is thus ca.1600. The roof structure of the rear wing (figure 13) has some re-used timbers but the two end trusses have cambered collars and could also be of ca.1600. They are pegged and the purlins are joined at the trusses with free tenons, very much a post-medieval technique. (Figure 14)

**Figure 12** Stone mullion window to cellar
