THE OXON RECORDER

SUMMER 2018

Granary or dovecote? An outbuilding in Appleton

An OBR working group recently had the opportunity to survey a small outbuilding in Appleton. The aims were to understand the dates, phases and uses of the building. Of these, pinning down the original use of the building became the most problematic, and provides the focus of this article. The full report will be Report 357 in the OBR database.

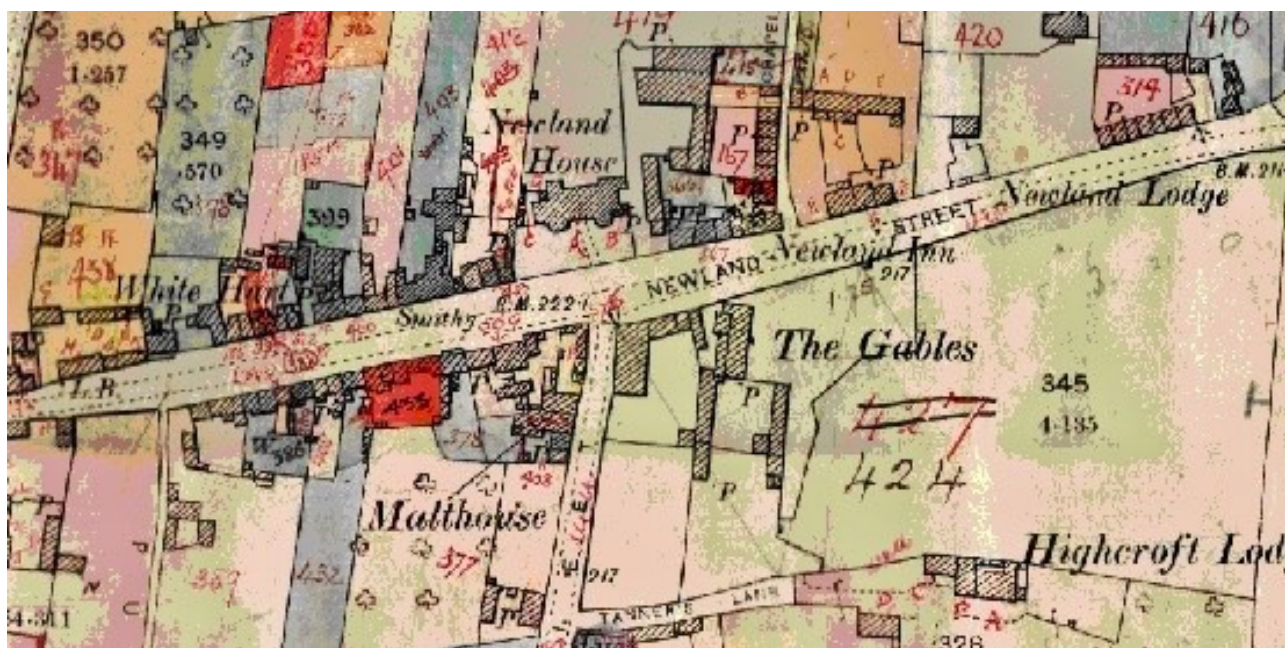
Figure 1. Extract from 1910 DV map (Reproduced by courtesy of the Oxford County Council – the Oxfordshire History Centre) (https://www.oxfordshire.gov.uk/cms/sites/default/files/folders/documents/leisureandculture/history/collections/districtvaluation/DV-VIII-351_Oxfordshire_XXXII-8.pdf)

But we started at The Gables (Figs.1 and 2), in whose Music Room we had held the AGM.

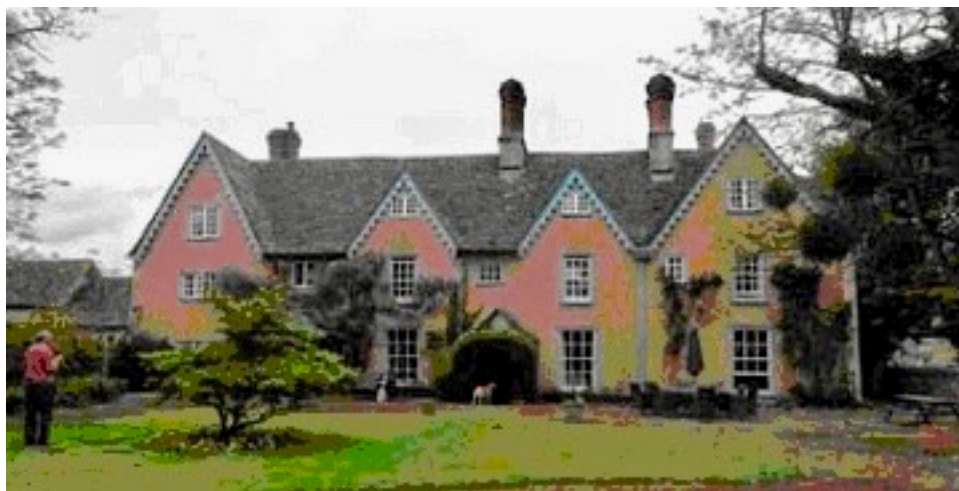
Figure 2. The Gables

Although given a unified exterior in 1838 by James Swann, who also owned and operated Eynsham Mill, behind the gabled façade is evidence of four timber-framed structures – two cross-wings at each end, a central range, and a 19th-century pentice corridor linking these at the rear. It has a complex development history, with some datable in situ features such as an early 17th-century open-well staircase with splat balusters and an early 18th-century bolecion-moulded fire surround. In Swann's time, the mill specialised in paper-making, and one of its products was praised by J C Loudon in the early 19th century as an innovative roofing material, which we noted had been used on the very low-pitched roof of the maltings (ca.1820) just behind the Gables at the corner of Queen Street and Newlands – Fig.3. (For more on this, see Malcolm Airs, 'The Strange History of Paper Roofs' in Transactions of the Ancient Monuments Society 42 (1998) pp.35-62).

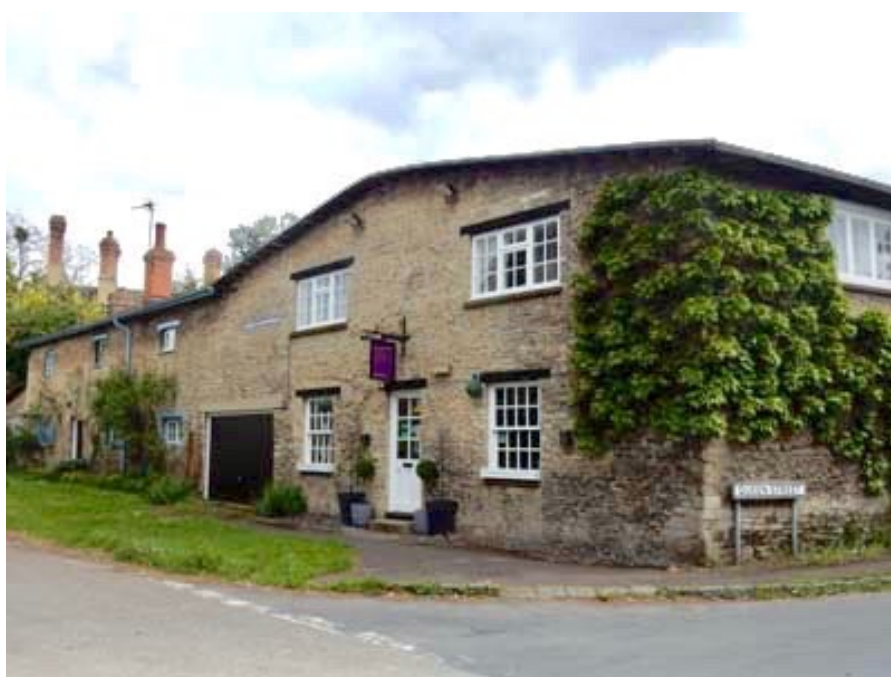
Figure 3. The Malthouse

In the main, walls in Eynsham are of limestone rubble, though there are a number of brick cottages, such as a pair opposite the entrance to The Gables, the clay probably having come from Eynsham Heath. Some thatched roofs survive, though most were replaced by stone – and later Welsh – slate after a series of fires in the 17th and 18th centuries. Member Tim Jordan then led us on a short detour into the courtyard of his thatched barn on Newland Close where he showed us a piece of abbey stone – look carefully at the walls in Eynsham and you will see many more.

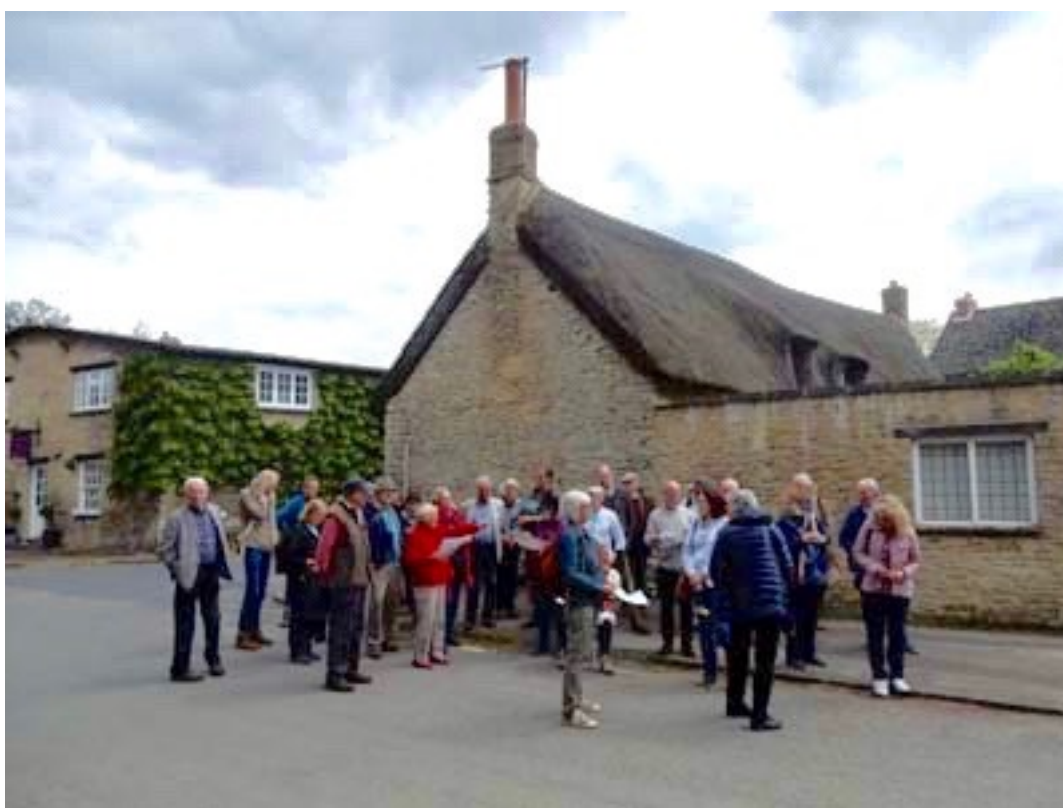
Figure 4. OBR members in front of Cobden - one of the surviving thatched houses

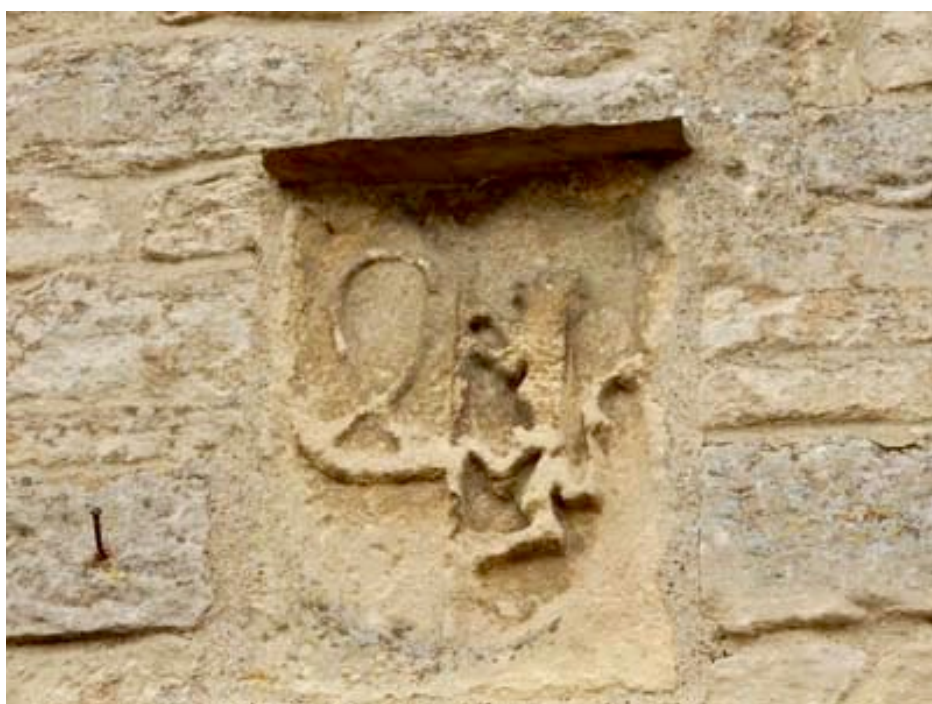
Figure 5. Reset stone on Bartholomew Room

Our last visit was to the Bartholomew Room, endowed in 1700 as a schoolroom/courtroom above an open market area (like Watlington). The upper room – now the parish council meeting room – still has the boards listing the donors, a valuable list of the great and the good.

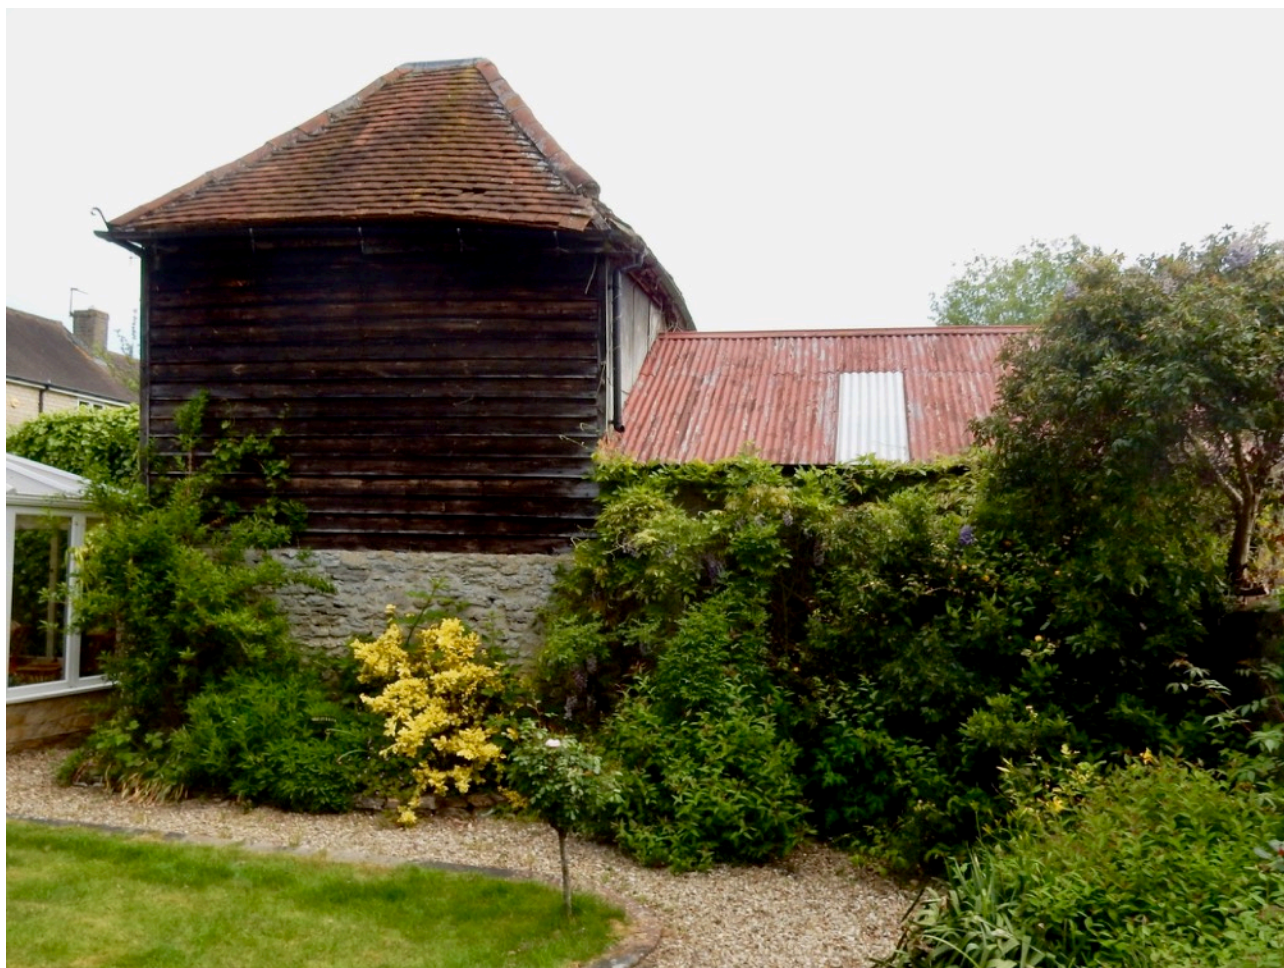
The outbuilding © D Clark

This article concentrates on structure B. It has a square plan, and consists of a stone basement with a weatherboarded timber superstructure topped by a truncated pyramidal roof clad with plain red tiles containing a roof-light. At first glance it looks like a dovecote.

However, the Grade 2 listing describes it as “*Granary, now outhouse. Early C18. Weatherboarding over close-studded timber frame of light scantling, above high limestone plinth; pyramidal old tile roof. 2 storeys. One-bay range. Timber lintel over entry to ground-floor store, and first-floor side-entry to granary. Interior: exposed timber framing, with notches cut on posts which marked the amount of grain stored. Included for group value.*”

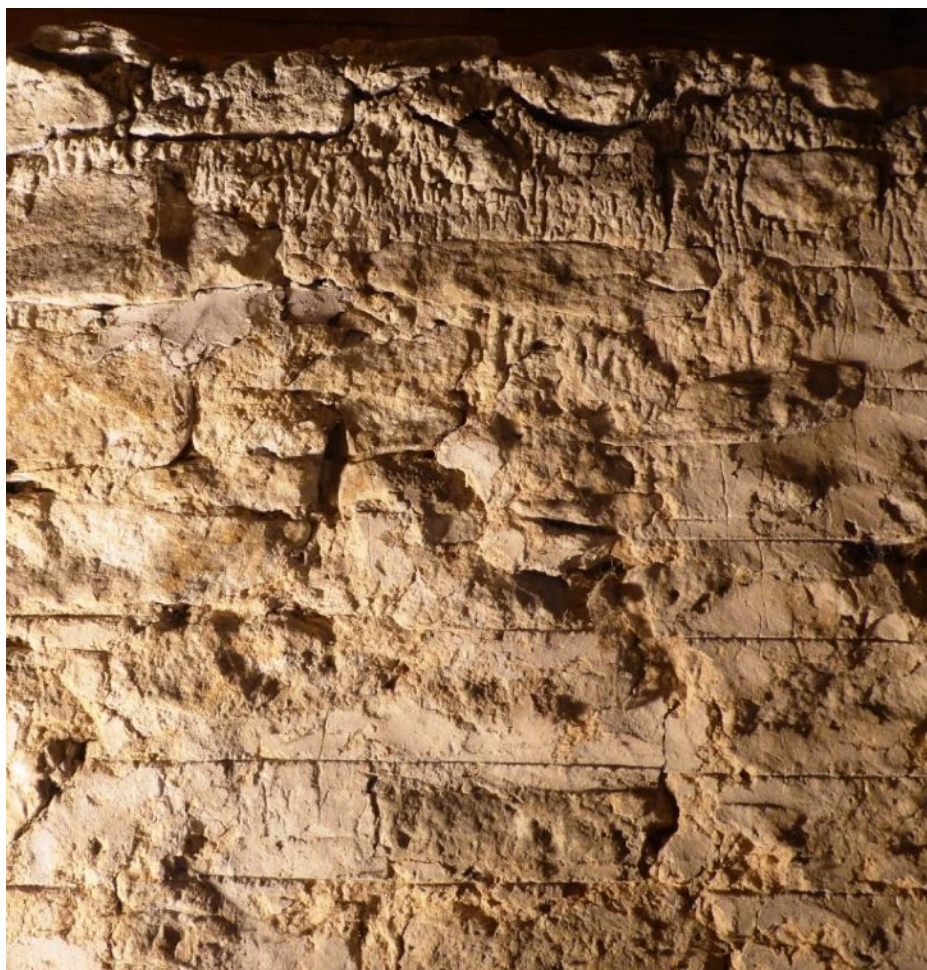
The space inside has a cellar-like feel, with no windows, low doorway, low ceiling, and earth floor some 0.4m lower than current outside ground level. The stonework towards the south west corner has some suggestion of rebuilding, though it could not be determined whether this was to repair collapse or to close a former opening. Much of the internal wall surface had at some stage been plastered and lined out, perhaps keying for a later coat. Eroded vertical channels in the soft plaster implied that liquid had drained from above at some time in the building's history.

Ground floor plaster lining and erosion © H Horner

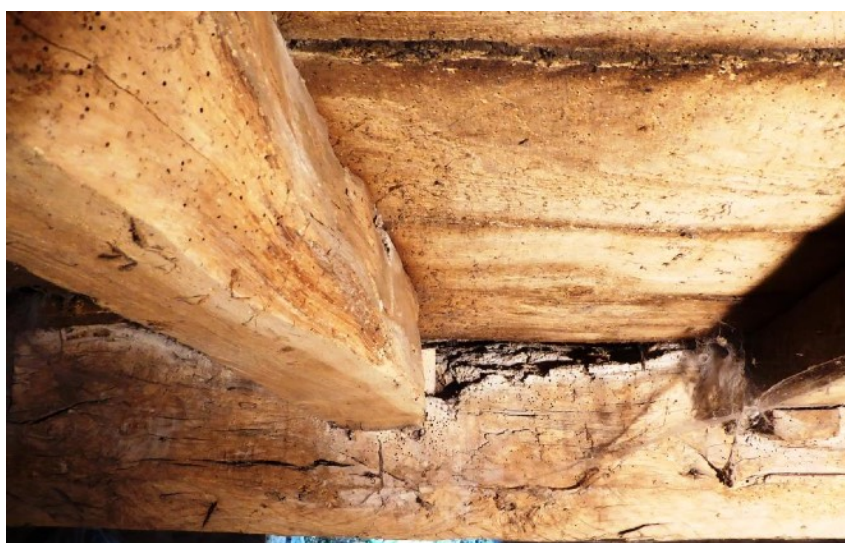
A continuous timber sill for the upper floor timber framing is visible from inside, placed towards the outer edge of the top of the stone wall. Peg holes are visible in the sill plate, coinciding with the studs of the upper walls. A central spine beam runs from north to south, tenoned into both sills and resting on the stone walls. The beam is heavily weathered on its upper face (only) in the centre of the building, which progressively lessens towards either end (and very little weathering at either end).

Spine beam decay © H Horner

The beam supports 8 pairs of joists, the central ends of which are each dropped into a mortice in the spine beam, and the outer ends lodged over the E and W stone walls and butted up to the sill plate. The joists over the doorway are softwood replacements, nailed to an added timber lintel; however, all the other timbers are of elm, converted with a pit saw and side axe. On one side of the spine beam, the joists support elm planks of varying widths; several of the planks have been firred up over the joists, suggesting re-laying at some time. On the other side of the beam all the planks are softwood replacements, without close butting or tongue-and-groove; these form the floor of storage bins on the floor above.

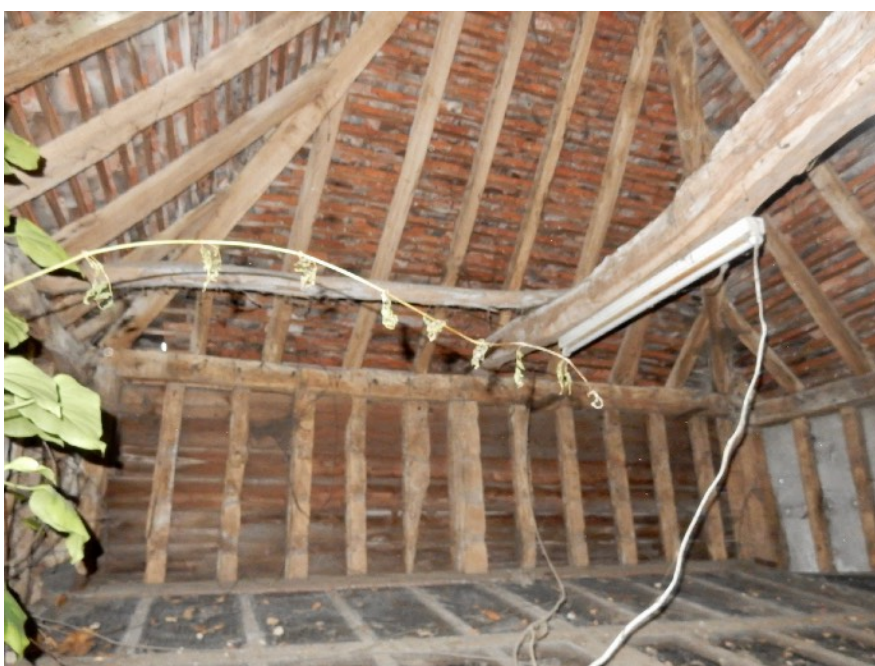
Upper floor © D Clark

The upper space is entered through a doorway from structure A by means of a wooden stepladder. It has a plank floor, and wall-frames of vertical timbers – with no bracing – to which weatherboarding (and asbestos sheeting to the south) is nailed.

At each corner is a thick post 23cms (9 ins) square, supporting the wall plates and hip rafters. The northern and southern wall plates rest on top of the posts and are clasped to them by the western and eastern plates. These are pegged in place to tenons at the top of the post. The hip rafters are also pegged to these wall-plates. The central post of each wall-frame is wider than the others (15cms, 6 ins) and is double-pegged to the wall-plate. Between these posts are 5 studs in each part of the frame single-pegged to the wall-plate and to the sill below. All these timbers are elm.

There is a single transverse tie-beam between the east and west wall frames. The tops of the hip rafters are supported by a pegged timber square in the centre of the roof. This also supports the two full-length common rafters of each roof-frame. The other rafters are truncated and nailed to the hip rafters. Most of the rafters appear to be oak, pit- or machine cut with sharp arrises and no sign of insect damage.

It was not possible to examine the square structure at the top of the roof at close quarters, but its outer surface is clad in lead or zinc and it may have at one time been open and have supported some form of louvre.

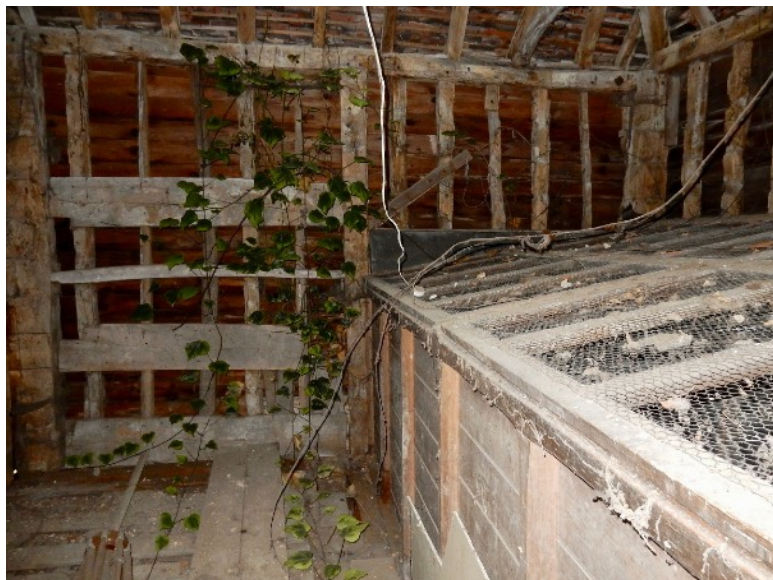
Storage bins © D Clark

The eastern half of the space is taken up by two large storage bins with wire mesh covers. These were clearly later insertions, and are presumably the basis for it being listed as a granary.

The removal of the nesting boxes and installation of the storage bins could have been done towards the close of the 19th century. The latter are well-made and have a turn-of-the-century 'feel' – tongue-and-grooved planking came into general use after 1885, and although a machine for making chicken wire netting was apparently developed in 1844, its relative thin-ness suggests a later date for this, but the use of wrought iron nails suggests that the blacksmith was still working in the traditional way, and had not yet moved into servicing motor vehicles.

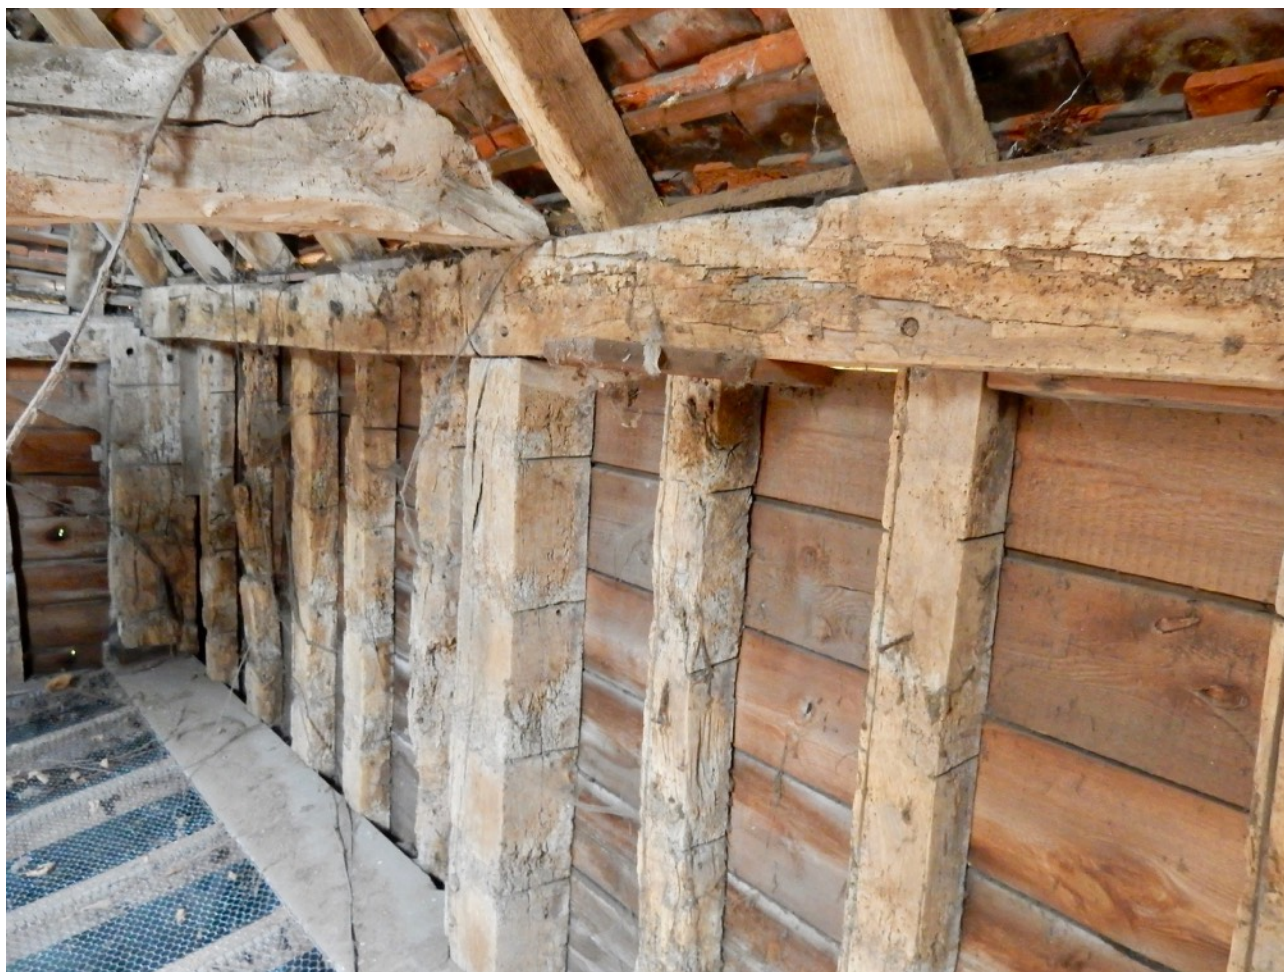
1. Down the left-hand side of each stud and post was a carefully cut U-section groove (1/8in. wide).
2. This groove was carried upwards into the wall-plate with a crudely chiselled groove on the same alignment.

3. At intervals on the left-hand face of the posts and studs were further U-section grooves. The distances between these were approximately 9 ins, but with differences of 1-2 cms. Some were perfectly horizontal; others had a slight slope. They had been made while the exterior was not weatherboarded, as the outer edges were clean-cut.

4. While almost all the timbers had signs of insect attack, this was particularly concentrated in a section of ca. 2ins deep at and above these horizontal grooves. This area also had discoloration and the timbers were degraded, but it was not clear whether the insect attack had preceded the degradation, or vice-versa.

5. The corner posts had signs of a different type of insect damage – the bore-holes were of larger diameter than the woodworm-like flight holes on the studs.

6. Near some of the horizontal grooves were small wooden blocks fixed to the studs using a single wrought-iron nail.
7. There were two rows of empty augured holes in each of the vertical timbers in the wall. They were 1in in diameter – as against 5/8 in. for the pegs in the structural timbers.

Vertical and horizontal grooves and timber discolouration © D Clark

Key to the answer to the first question is the insect damage around the horizontal grooves. Of the various possibilities, four types of insect could have been responsible:

- Lyctus powderpost beetle, found in oak and elm sapwood, often in stockyards.
- Ptilinus beetle, also found in hardwoods in stockyard contexts.
- Wood-boring weevils, who favour damp conditions, and attack following fungal decay.
- Moths, also in damp conditions with holes where infected material is in contact with wood.

Detailed study of the bore-holes and residues may refine this analysis, in particular whether the holes and timber decay are contemporary, but it seems clear that the differential attack pattern on the posts and studs is related to shelving in the grooves, and although it is difficult to see how nesting boxes were fitted into the structure – and why such a complicated method was employed – the conclusion that the primary purpose of the building was as a dovecote seems incontrovertible. This would also explain the square structure at the apex of the roof, which would have supported the Glover or louvered structure through which the birds entered the building.
