The Oxon Recorder is the newsletter of Oxfordshire Buildings Record and is published four times a year. OBR aims to advance education and promote research on the buildings of Oxfordshire by encouraging the recording of buildings and to create and manage a publicly accessible repository of records relating to such buildings. The Oxon Recorder is also available in the members' section of our website: www.obr.org.uk

OBR lecture: Standards, Spikes and Swedish Ironstamps

OBR Presentation Day

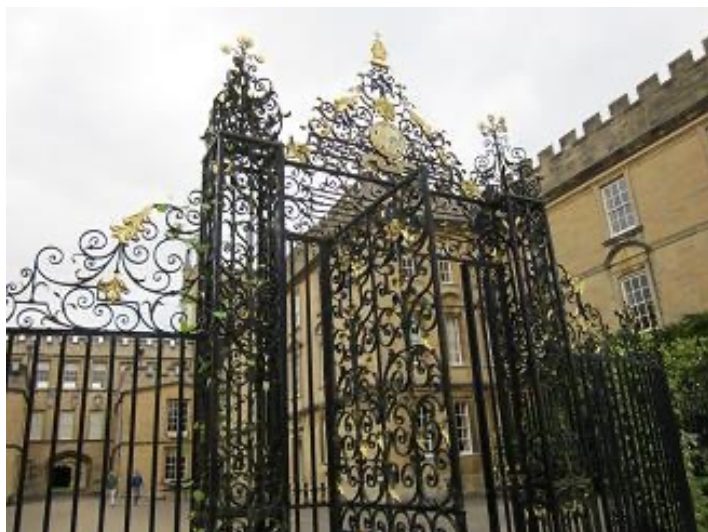
New College garden gates

Their invisibility implies that they are insignificant. For example, the New College garden screen is described in detail in the literature – we know the designer was the gatesmith Thomas Robinson of London, and it was built in 1711. But while the gates themselves are probably as Robinson made them, no-one mentions that the railings to either side were replaced in replica by Wm Lucy and Co. in 1894.

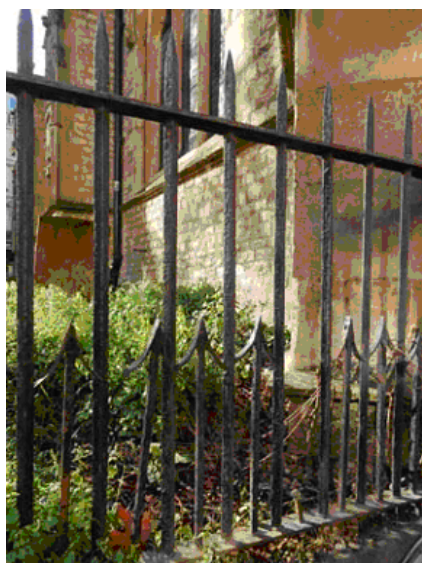
St. Mary Magdalen railings..... broken stubs of earlier railings

When damaged or corroded beyond repair, ad hoc replacements/repairs have been made, sometimes on an apparent 'like for like' basis, but often there are various clues to suggest that this has not been exact. For example, the churchyard of St Mary Magdalen has 19 different types of railing: but even those to the north and south churchyards are not the same, and the repaired sections are clearly different – largely due to the use of lower rails – where sometimes the broken stubs of the earlier railings can still be seen beneath.

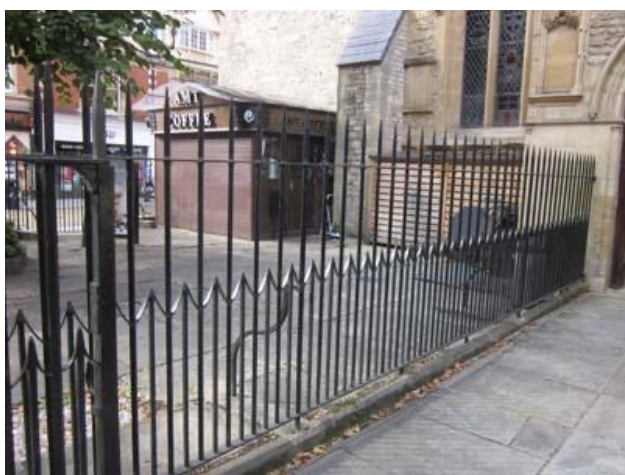
times by the replacement of historic railings by mild steel or even non-ferrous materials. Deliberate attempts are made to make the new look like the old. Thus the railings around the coffee stall in Cornmarket at St Michael at the North Gate are of mild steel and were approved in 1997, on the basis that they 'shall match those adjoining, erected in 1992, including hammering of the metalwork to imitate the appearance of wrought iron.'

St. Michael at the North Gate; modern imitation in hammered mild steel

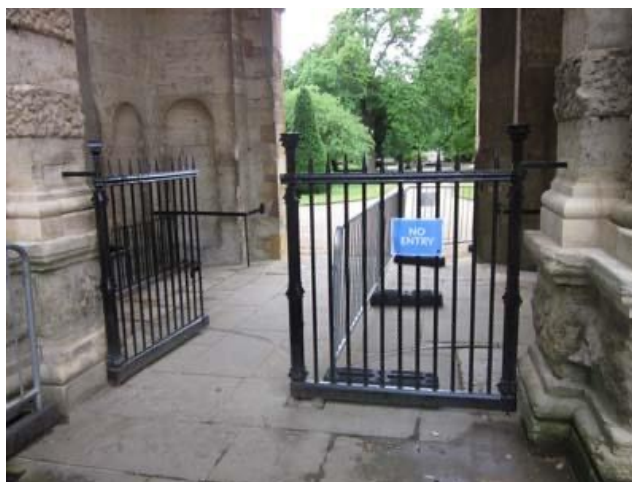
Danby Arch; reuse of medieval tomb railings

There are candidates for some really early ironwork in Oxford. The Botanical Gardens' Danby Arch gates were made using medieval ironwork, although they were not installed until the nineteenth century. The railings around the Sheldonian Theatre were first erected in 1669, and the Judge's Lodgings in St Giles dates from 1702, but what is now there is unlikely to be as early as this – except perhaps for some at the north side of 16 St Giles. However, David identified as definitely 18th century railings around the Clarendon building quadrangle and the gate and screen of St. Mary the Virgin. As already noted, the railings at All Saints (now Lincoln College library) may also be 18C.

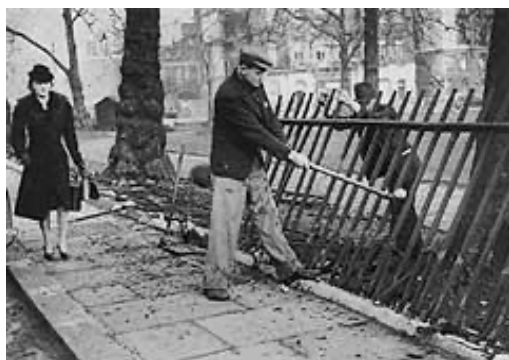
WW11 destruction

Then there was the wanton destruction of railings during the Second World War. There is plenty of evidence of iron stubs and holes in stone plinths where they once were, such as around a narrow garden in front of the Catte Street screen of the Clarendon Building, and at St Mary Magdalen.

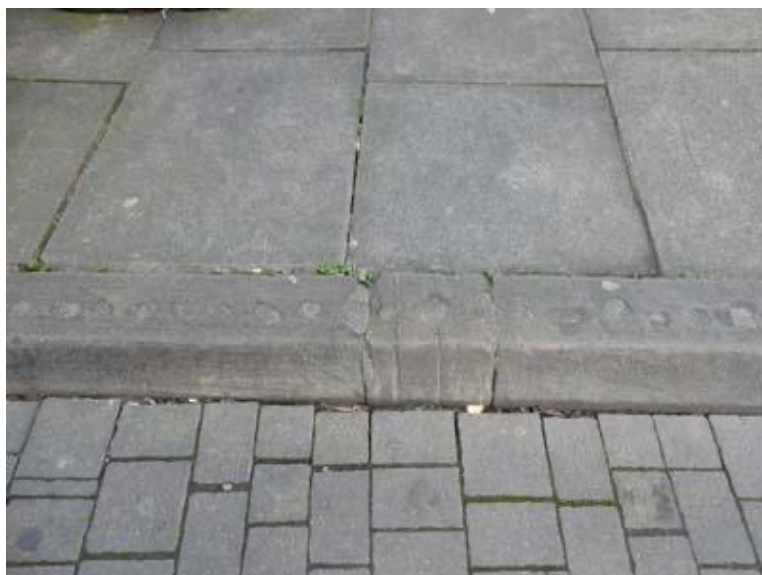
The evidence: filled-in holes

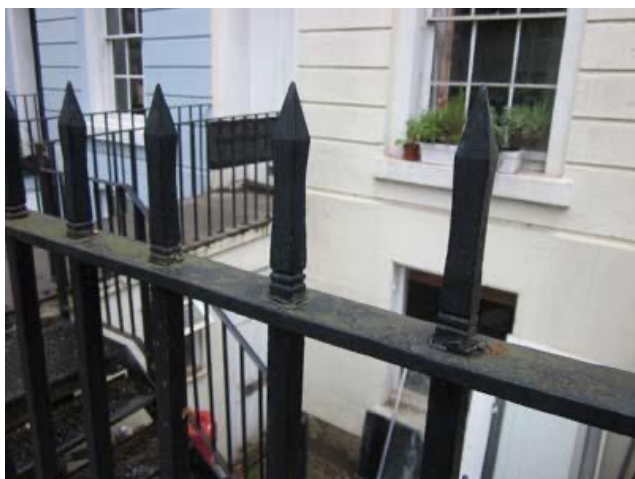
Walton Street lightwell

What saved many sets of railings was the fact that they protected entrances to areas such as the deep lightwells, storage areas and below-ground access doors to many properties in the city. Examples can be seen in London Place (from 1830s) and in Walton Street (from 1858). Railings are regarded as utilitarian, not 'decorative'. Although there are some 23 sets of separately listed gates and railings in Oxford, they are almost never mentioned in books on Oxford's architecture. Often this is only because they are associated with gates, gate piers or other more 'architectural' features. These list descriptions often show signs of having been made on the basis of a cursory glance without doing any research to verify the statements made. Two glaring examples are the railings north of the tower of St Michael at the North Gate, listed as 'mid C19', yet there were buildings hard up against the tower until 1900. Even worse is the Peckwater Quad screen to Oriel Square, listed at Grade II*. The description states, 'probably by Dean Aldrich (1648-1710). C18'. Yet this is based on a misconception, as the screen relates to the construction of King Edward Street in 1872, with the screen erected seven years later in 1879.

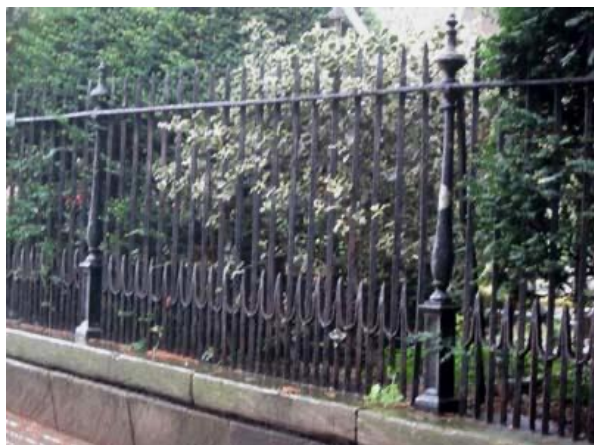
On the other hand, some sets of railings are given a C19 date, whereas they may be considerably earlier. For example the railings at the library of Lincoln College – the former All Saints church – where the railings are somewhat similar in design to those of 1730 at Senate House, Cambridge, and could quite easily be of this date in Oxford as at this time Lord Crewe donated money to erect the steeple, and there may have been spare funds for railings at the same time.

**Railings at Lincoln College library
(formerly All Saints Church)**

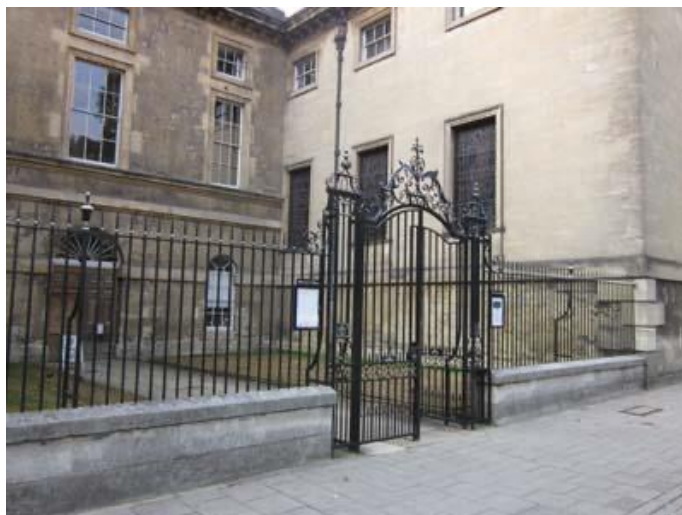
Worcester College screen

An excellent case study example is the chequered history of the gate and railings at the front of Worcester College. Listed as 'C18', this is indeed the date when the college was refounded and the grand entrance façade of chapel, hall and library behind, was constructed. But neither Hawksmoor's drawing (Colvin 467) nor Burghers plan (1720) shows a screen, though there is a Thomas Gough (of London) design of 1735 in the college archives (Colvin 471) and another of 1775 by Henry Keene (Colvin 476).

However, in 1870 Richard Lynch Cotton (a Fellow from 1816 and Provost from 1839) donated a new gate and railings, including a shield with his initials and a number of rosettes. William Drake, who started work at Worcester College in 1881 at the age of 13 and retired as college butler in 1946 recalled: ‘I can't express my feelings of sorrow when I saw five men breaking them down with hammers and carting them off to a marine-store dealer as scrap-iron.’¹ Cotton's screen is shown in a Taunt photograph of ca. 1900. In 1938 Cotton's screen was removed – but the timing was unfortunate, as during and after the war the front of the college became a car park and it was not until 1951 that new railings and the gate were erected – using the 1735 Gough design as a model. So again the listing is wrong.

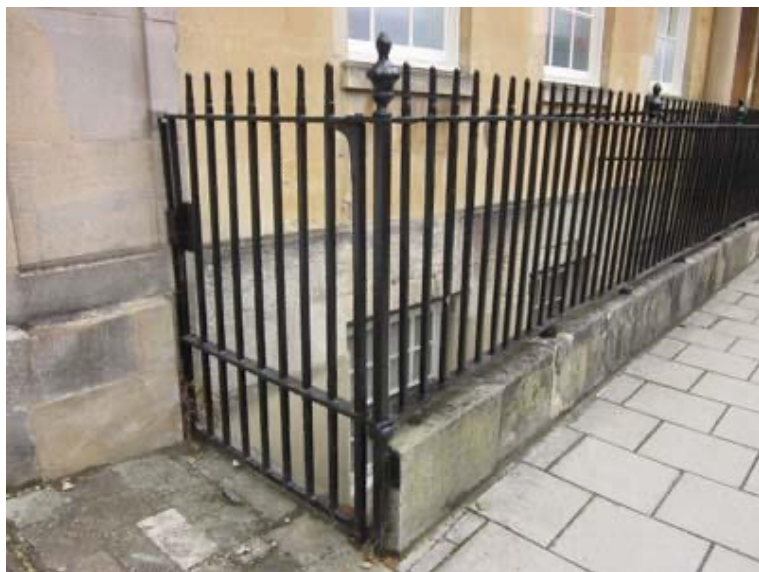
15 St Giles

There are many more candidates as survivals at least in part since the early 19c. 14-15 St Giles (ca. 1820); Hertford College (ca. 1822); Christ Church Meadow - Rose Lane gates (before 1820); Folly Bridge (ca. 1827); University Press, Walton Street (1828); 34-36 St Giles (1829). These railings have a number of typical features: wrought iron, with some cast iron

for finials; no lower rail - set directly into the base plinth - often diagonally; grouped standards as piers; simple spikes with decorated necks; spearhead tops.

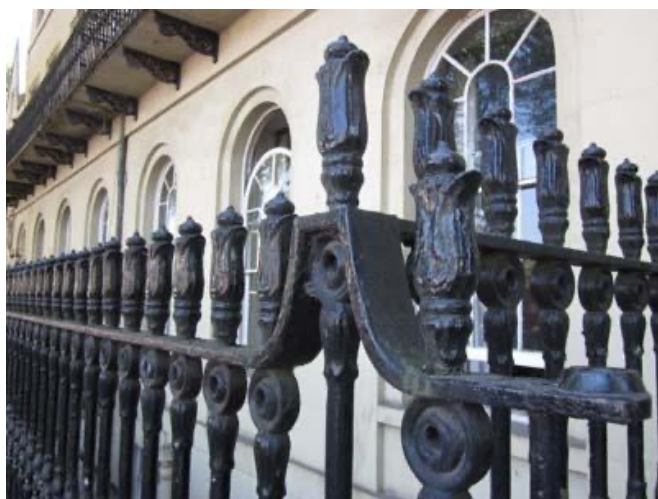
After 1830 cast iron becomes ubiquitous. Examples are St Benet's Hall in St Giles (1830); St Pauls in Walton Street (1836); St Thomas' Girls School (1842); 132-170 Walton Street (1858 onwards); University Parks (1865); New Road Baptist Church (1874). Typical features: almost universal use of cast iron; lower rails more common; spear tops give way to flowers and leaves; green paint popular.

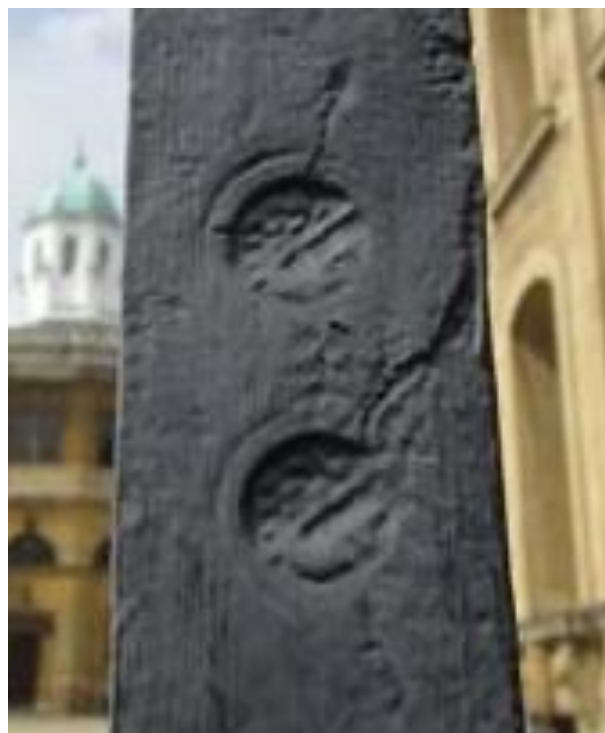
**Gate****Ironstamp on railing****Clarendon Quad**

Booth took over the Tijou business in 1712, and was familiar with his working methods and suppliers. The railings contain cast and wrought elements, but what is particularly striking is the number of marks stamped into the wrought iron standards. They are Swedish ironmasters' identification marks, and acted as both origin and quality identifiers.

In 1604 the Swedish government required each town to have an 'iron controller'. In 1637 each forge was required to mark every iron bar that it made, in order to safeguard the quality and to track it through weigh-houses and bonded stores to export. It was also the basis for a quota system. The mark was applied to the iron bar during hammering.

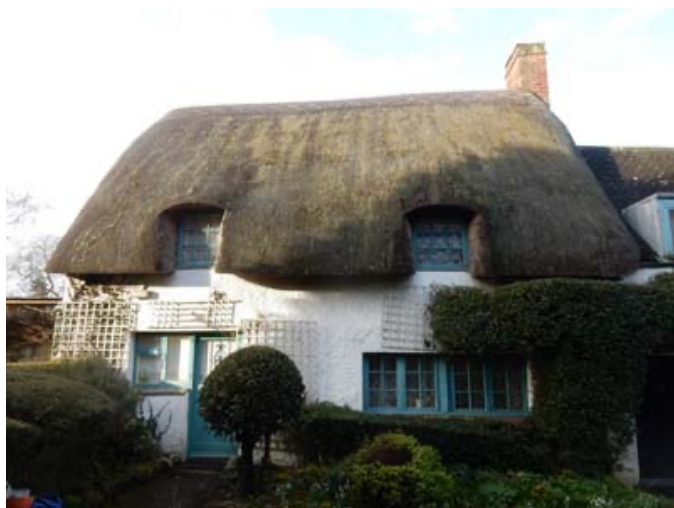
South range

What is identifiable in the 1876 1st edition OS map is now a 1 1/2 storey thatched cottage with a 2 storey tiled north range, connected to each other by what is now the main entrance hallway range. Both main ranges are built of rubblestone - the north range being more regular, and both have brick chimney stacks.

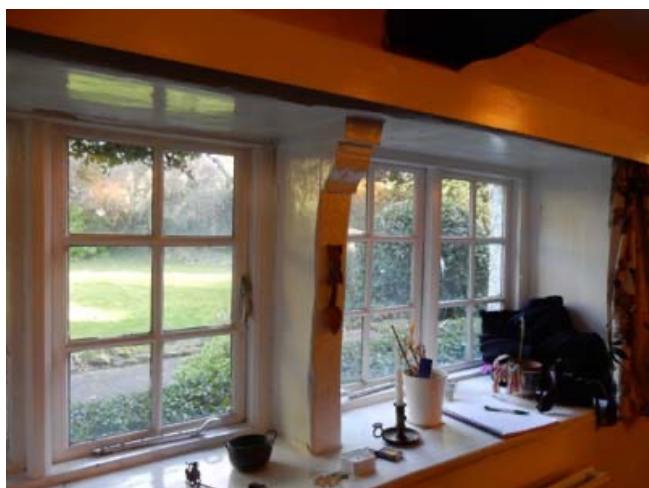
Casement window with king mullion

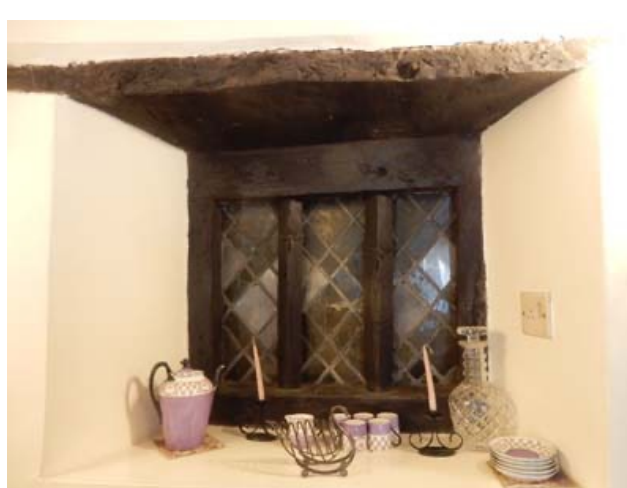
Blocked window

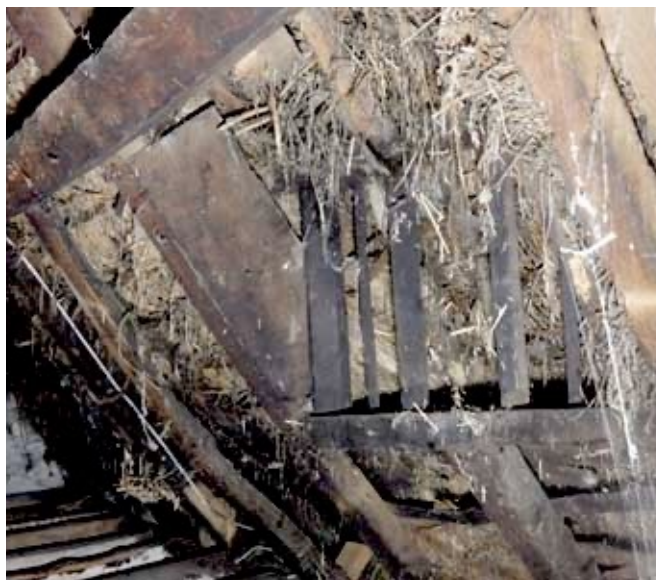
The thatched range features threaded purlins, a missing collar, and one straight wind brace. There is some sooting of timbers. Possibly the purlins extended beyond this range into what is now the connecting hall range. The rafters have scratched assembly marks. Now covered by thatch is a diamond mullion window frame with stanchions still in place and pintles

Threaded purlin

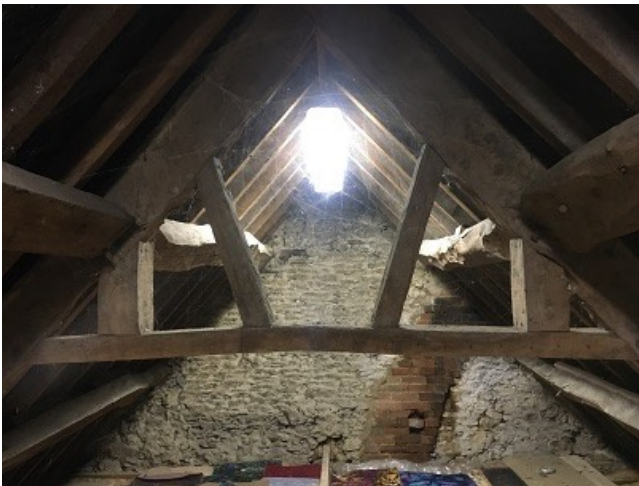
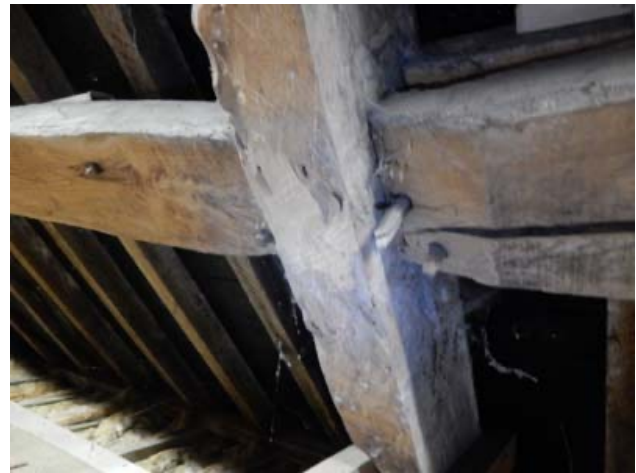
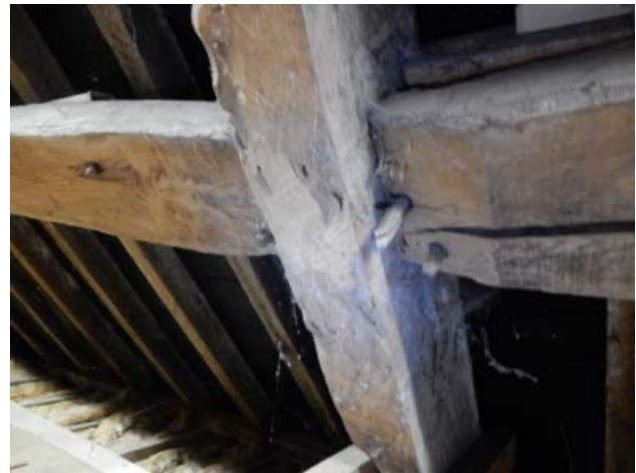
The main timbers of the tiled range are elm, with two tiers of purlins fixed using loose tenons. there are chiselled assembly marks and an axed level mark. The central truss is an A frame with added timbers.

Tiled range

Central truss

Loose tenoned purlin

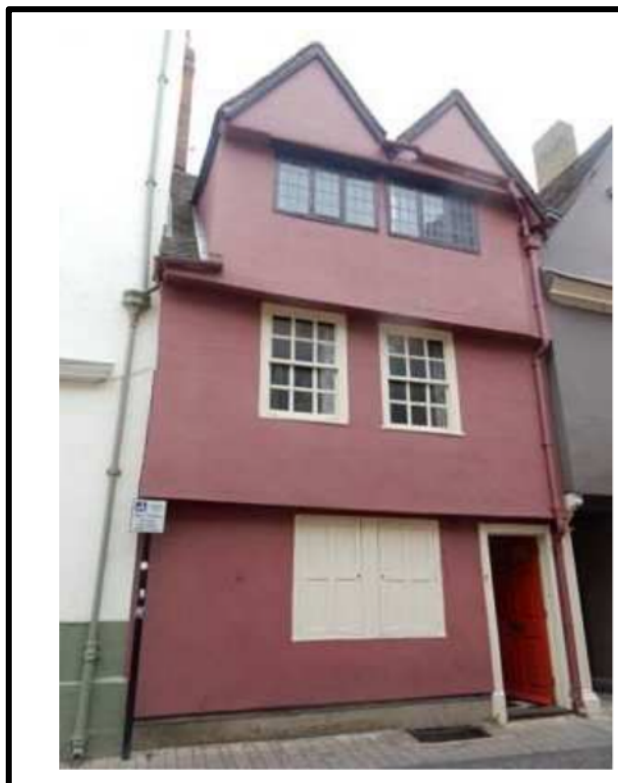
38 Pembroke Street, southern elevation

Abigail Lloyd reported on her research into 38 Pembroke Street with David Clark. Its Grade 2* listing describes it as “C17 in origin. 3 storeyed stuccoed rubble and timber framed with cellars, an overhang on 1st and 2nd floors and two gables...Inside, there is some C17 panelling the design of which is thought to be unique in Oxford...There is a winding oak staircase...This and no 39 probably forms the house ‘lately built’ in 1690.” One purpose of the research was to validate these particulars.

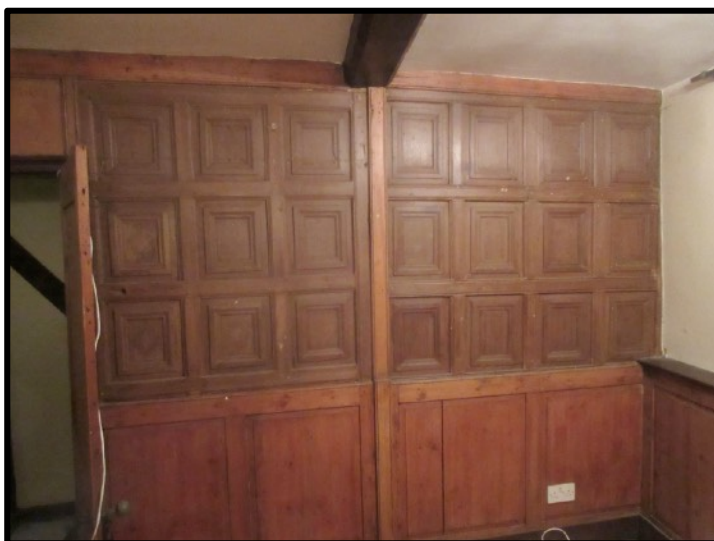
As the listing particulars note, the panelling of the ground floor partition wall is of special interest. This was first documented as unusual by an unpublished survey by Bunney and Pearce in the 1930's, relied on by the Royal Commission on Historical Monuments in its 1939 inventory of monuments in Oxford. The panelling features two slightly different designs, and glued on additional decorations, some of which have been detached but are indicated by shadows of less faded wood. These geometric lozenge decorations are typical of the 1620s or 1630s.

Panelling and glued on lozenge decoration

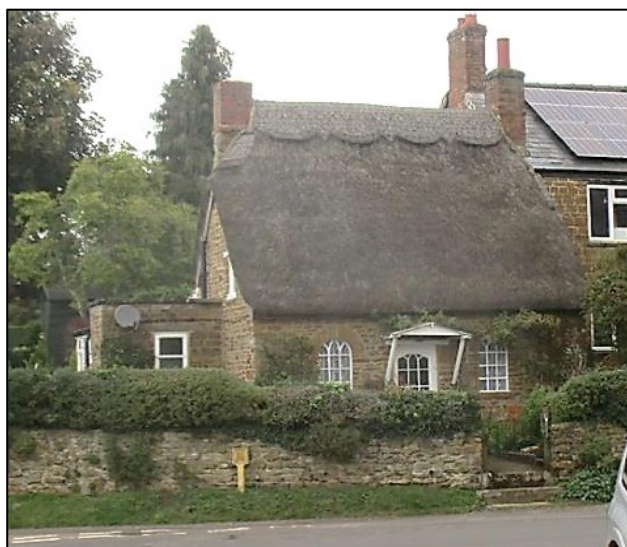
The first house he described has gable chimneys, a symmetrical facade and cast iron Victorian gothic window frames and glazing bars, suggestive of construction in the century up to about 1850. It has small hearths, suited to coal burning, which would support dating construction in this period. However, it features a raised cruck roof truss which is clearly older, with pit saw marks which could be medieval, probably reused from elsewhere.

Victorian Gothic...

...hiding something much older

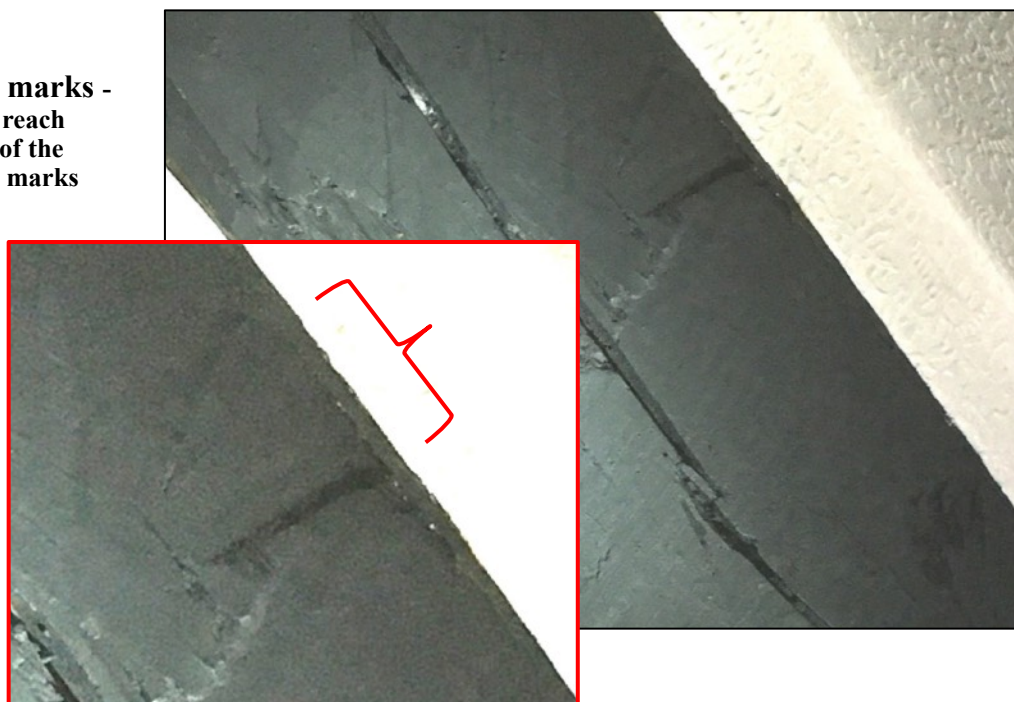
The second house has a date of 1676 carved into a principal floor joist, and the label moulds over stone mullion windows support an estimate of construction in the C16 or C17. Here again there is a raised cruck, topped by a cross piece, and a scarf joint at the junction of an upper and lower cruck rafter. Another apparent example of a build - in this case perhaps around 1676 - reusing a C14 or C15 raised cruck truss.

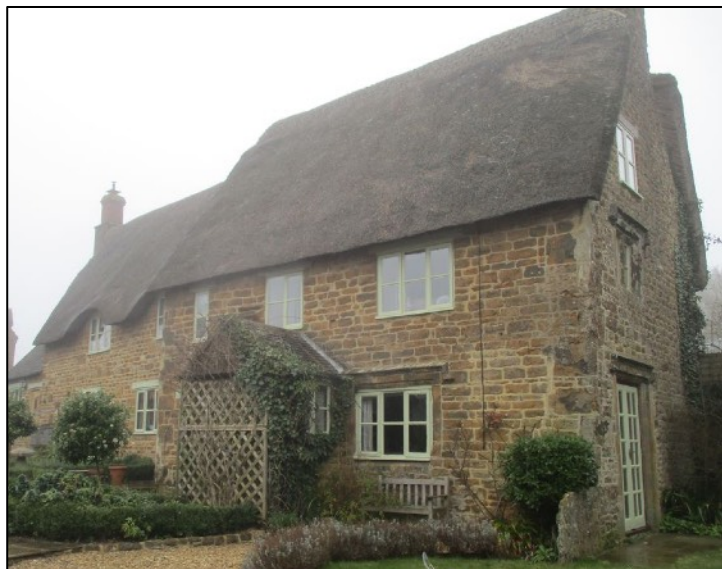
Label moulds over stone mullion windows

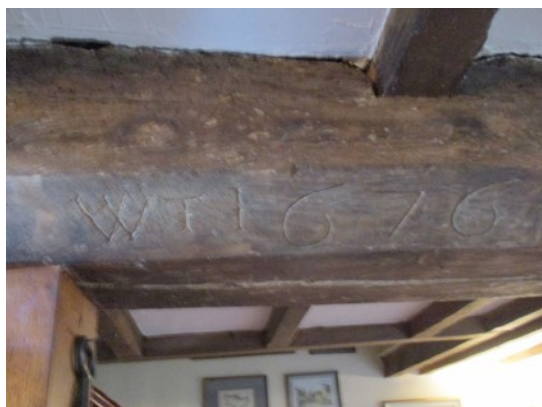
Scratched date

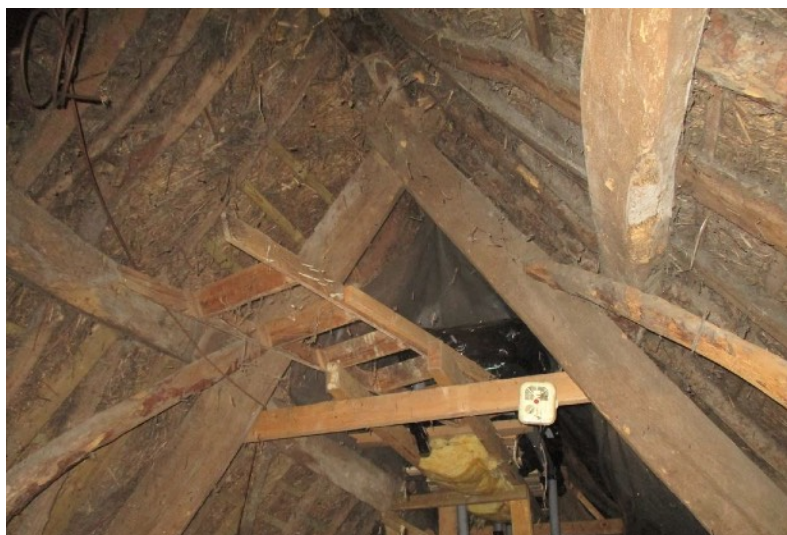
Another house, the outside of which could be early C17, also features a raised cruck roof truss, with ends crossing at the roof apex.

Raised crucks crossed at apex

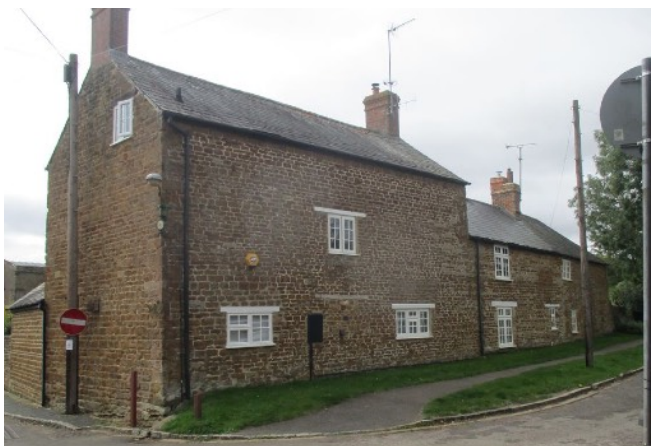
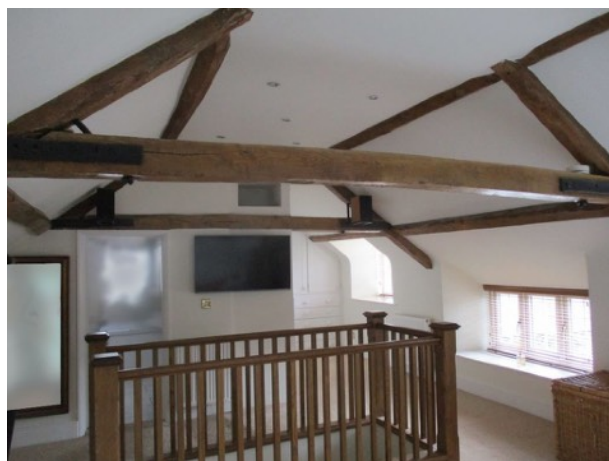
Paul contrasted these examples with a building where the roof was younger than the building. In this case the construction and use of iron straps indicated a C19 roof with raised eaves on top of older stone walls. The purlins were originally attached to the upper side of the principal rafters, although one truss featured a loose butt purlin, indicative of C18. Subsequently these were replaced by through butt purlins, indicated by a lack of peg holes on one side (and therefore part of the purlin).

Raised eaves on older stone walls

C19 iron straps

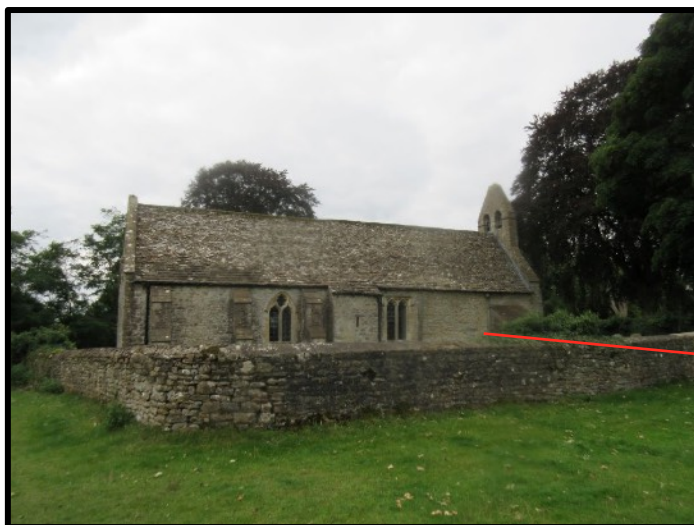
If it was a manorial chapel, where was the access from the manor? There is a filled in door frame on the north wall of the church nearest the site of the manor, but it is small and utilitarian.

North door access to the church from the former manor © A Lloyd

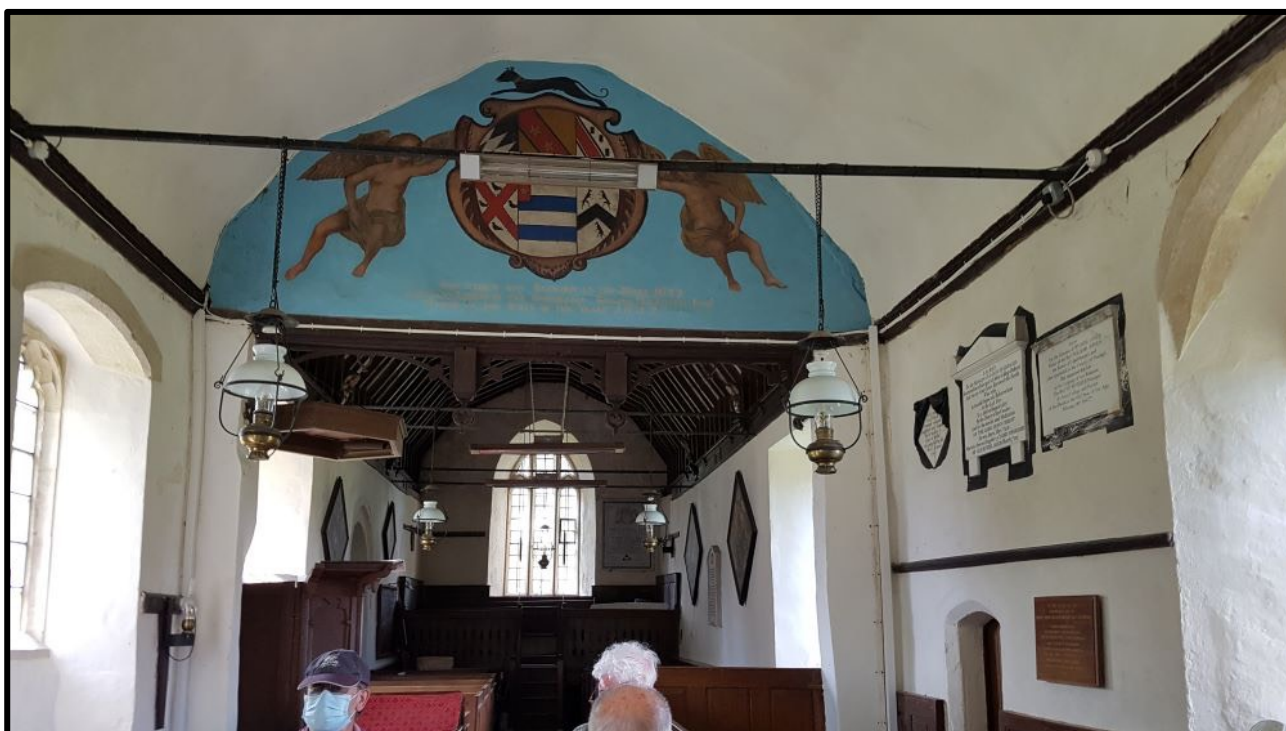
The church has a single cell appearance, but closer examination of the roof line and interior indicates that the chancel is slightly wider than the nave. Typically, parishioners are responsible for the nave and the rector - often better off - for the chancel. Could this indicate a parish role for the church in the past?

Chancel / nave internal division © A Lloyd

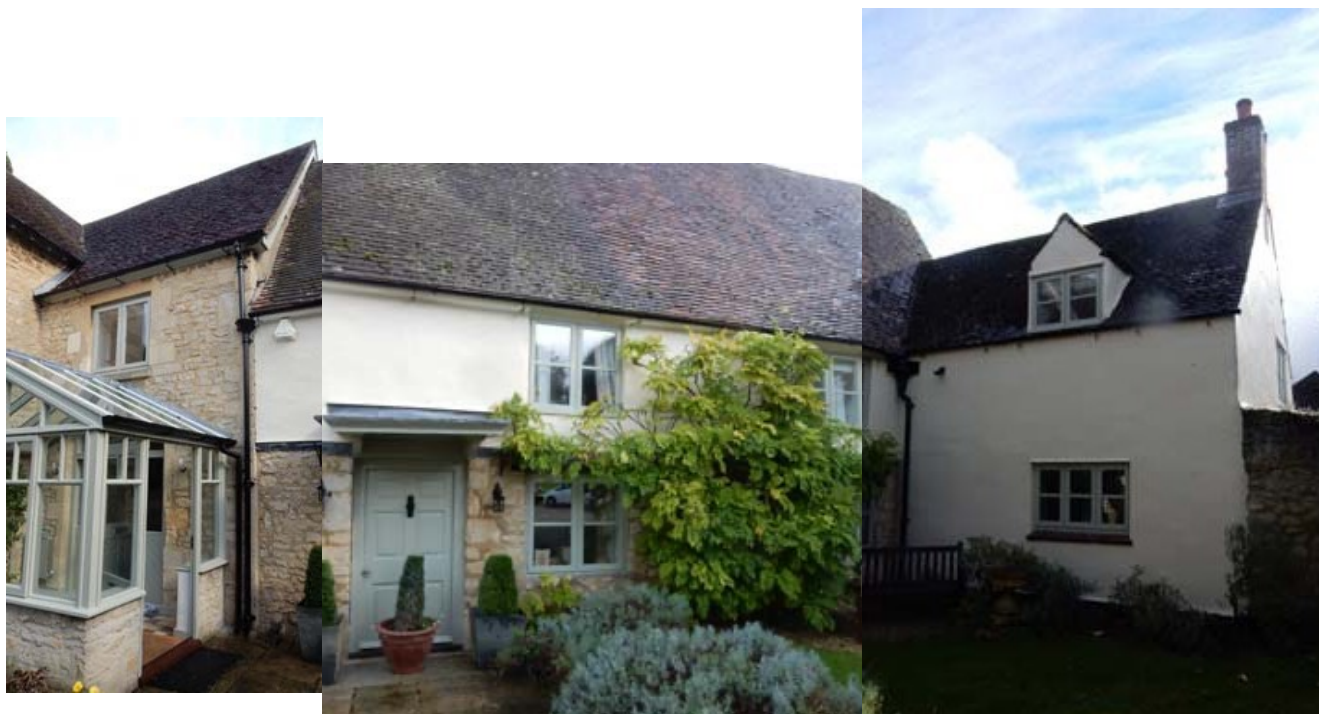
David Clark described a survey of Minchin Court in Forest Hill, a building with several elements, most clearly shown on its west elevation, which features uncoursed rubble stone walls, rendered first floor, wide former doorway, changes in roof pitches, and an appearance of being a succession of additional extensions. However, the present ground plan is similar to that delineated in the 1910 District Valuation map, so major changes are Victorian or earlier. The south and east elevations are also rubblestone with render above with exposed timbers above ground floor level, and a buttress at the south east corner. The north west elevation is a blank uncoursed rubble stone wall. A bay window range in the east elevation has large plate glass windows.

Minchin Court; West elevation (composite)

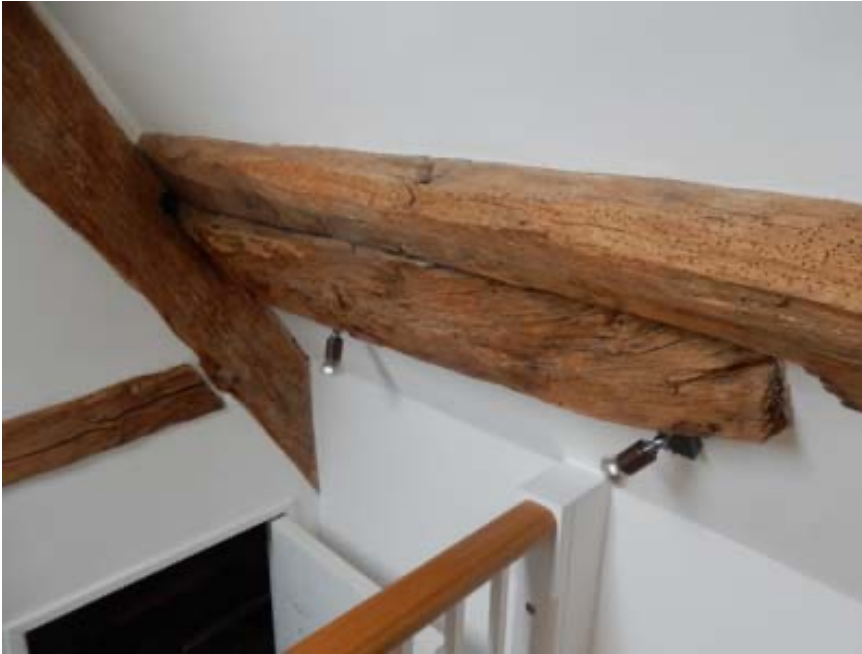
not smoked, rafters not paired and there is one wind-brace. Purlins extend to the north beyond their supporting trusses.

Purlin extension
