OXFORDSHIRE BUILDINGS RECORD REPORT OBR.124

Checker Hall Abingdon Abbey Abingdon

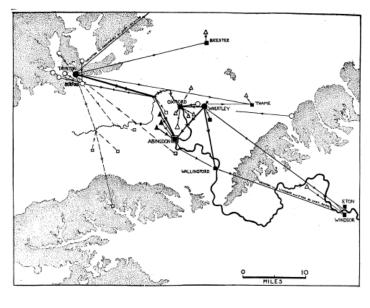
Figure 4 Source of stone for Abingdon Abbey (Jope, 1949)

Jope² documented the sources of stone used at the Abbey. Fig.4 shows the sites from which stone for the Abbey was drawn. Taynton and Wheatley stone (a quarry in

Wheatley was owned by the Abbey) were used for dressings whilst rough stone came from nearby quarries, possibly Hinksey, Sunningwell or Chilswell.³

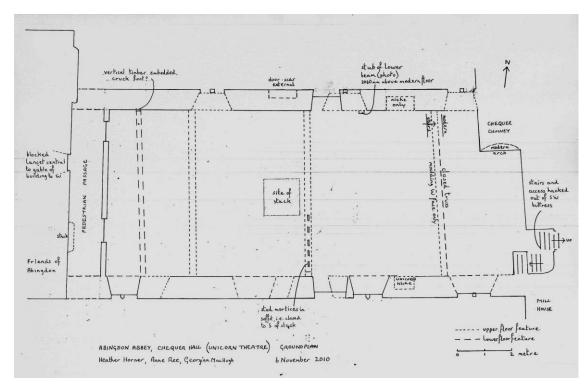
Figure 5 Checker Hall ground plan (H Horner)

The ground plan is shown at Fig. 5, drawn at 1:50 and reduced. Measurements were taken at waist height above the present ground level. Features above this datum are indicated by dotted lines. The pit of the theatre (the bay in which the former stack was placed) appears to be a $20^{\rm th}$ C excavation below the original ground floor level. The pit has not been included in the plan.

The Checker Hall has been inserted lengthwise into a space between two standing buildings, with its roof butted against the two existing gable walls at either end. To the west, the Friends of Abingdon house (No.18 Thames Street) has a gable wall which extends further to the north, wider than the Checker Hall building. A blocked lancet window visible from inside the theatre is probably central in this gable. There is also an external chimney stack towards the south end of the gable, which may have been in situ before the Checker Hall building was erected. To the east, the 13th century Checker building is utilised to support the roof, the massive chimneystack and southwest buttress are both visible from inside the theatre. The tie-beam of the end truss has been sawn though (presumably when an access was created at first floor level from the Checker building).

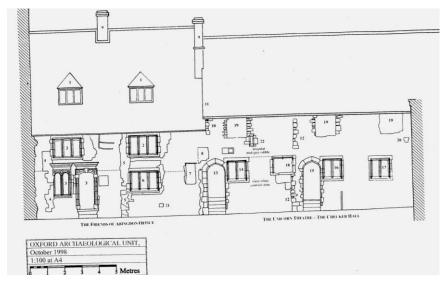
Figure 6 Archaeological analysis of south checker hall wall (OAU, 1998)

The walls are of roughly shaped and coursed rubble stone, some 750mm (2½ ft) thick, with few dressed quoins. Different sources of stone have influenced the appearance, some light grey (probably Corallian) dressed in large blocks in the western end of the south façade closely resemble the adjacent No.18, while the rest of the wall and the north wall are built of smaller darker stone. This may be the result of more than one phase of construction. There are many scars of re-fenestration in both the north and south wall, visible internally though less obvious externally. Oxford Archaeology made a detailed study of the south wall, and this is shown in Fig.6. Their comments on this are set out in Annex 1.

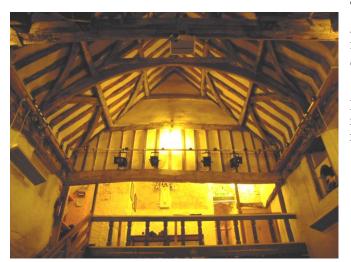
Figure 9 Closed truss from W, moulded W face of tie, plain on E face inside east bay

The eastern truss was closed from apex to the ground – there are empty mortices for studs and it is moulded only on the west face (facing into the hall) – Fig.8. At this truss and inside the eastern bay, the purlins are clasped by slightly lower collars (Fig.9).

building to the east. One purlin with a windbrace continues into this bay, which ends in a further tie-beam truss a short distance from the rear wall of the Checker.

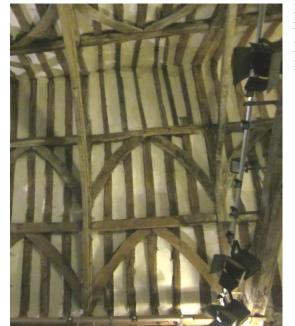
Figure 10 (left) Roof showing position of former stack

The common rafters have been replaced with ones of small scantling in some bays where roof dormers and the central stack had been inserted (Figs. 10, 11).

There is no sign of smoke blackening on any of the roof timbers. 19th century photographs show a central stone stack, removed at conversion to a theatre in the 1950s. The position of the former stack is visible in the roof apex just to the west of the central truss. There is no other evidence of heating.

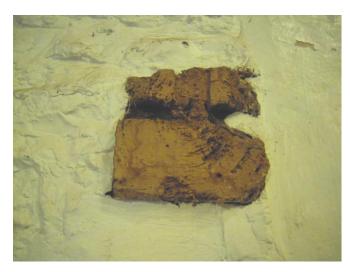
Figure 12 Stub of first floor beam, N wall, showing tenons for joists.

Two cross beams to support the first floor survive, one under the (formerly) closed truss at the east bay, the other currently used to support the proscenium of the theatre at the west end. It seems likely that these supported joists and a plank floor.

Stubs of further beams supporting the first floor are visible in the walls, presumably cut off when the building was converted to a theatre (Fig.12).

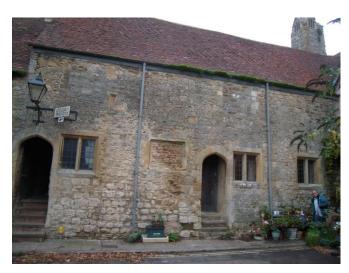
Figure 13 South elevation

The building has had many changes to its fenestration. Some of the upper windows and dormers are likely to have been blocked or removed at the conversion. The lower windows and doors in the south wall (Fig.13) and the surviving upper windows in the north wall (Fig.14) have a modern appearance, with neatly dressed but plain stone reveals and mullions. Splays and scars of at

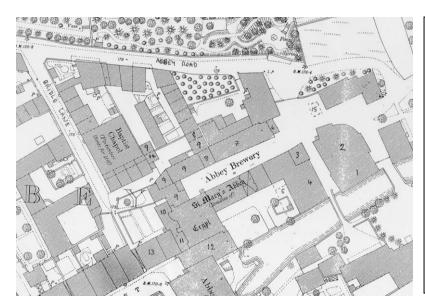
Figure 16 1st ed OS (1877) with buildings noted on 1867 plan of brewery

Many of the surviving buildings were used as a brewery, and continued to be used as such until 1887, when it was acquired by Morlands. A 'Plan of the Abbey and Brewery AD 1867' signed by 'N.P.P' was later traced by A W Woodruff, and photocopied by Elizabeth Drury. This shows the building layout at the time (Fig.16)

The Checker hall is clearly identified at 13 as 'Mr Sharpes' cottages. These are illustrated in a late 19th century photograph (Fig.17)

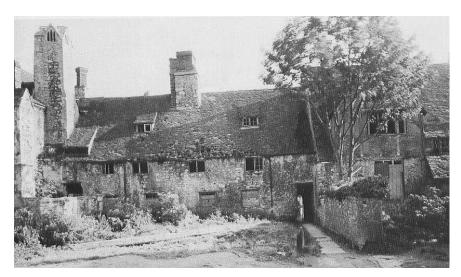
Figure 17 The Checker Hall as cottages (Thomas, 1979)

This clearly shows the massive central stack and various windows, including three sloping-roofed dormers on the north elevation. In the late 19th century the cottages belonged to the Dockar Drysdales of Radley. They were drawn by local architect J G T West in 1890 prior to an intended renovation, some aspects of which are noted on the drawings (Figs. 18 & 19). In any event, the aspect of the buildings when viewed from Thames Street is very much as it is today (Fig.20) allowing for the blocking of a number of the windows.

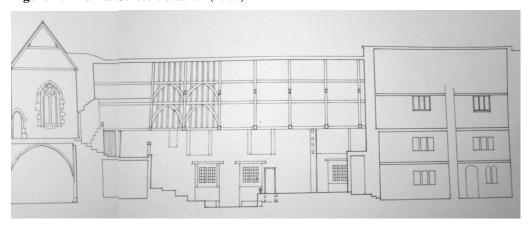
Figure 21 Abbey buildings (W H Godfrey, 1958/9, Friends of Abingdon)

Walter Godfrey felt that the Checker Hall was butted against the east wall of the abbey granary – in effect a storage barn such as that for New College in Oxford – with the east end converted for use as a bakehouse. It was bought by the Corporation of Abingdon in 1637 for use as a bridewell. Godfrey thought that the shell of the Checker Hall might be 14th century, with the eastern bay which 'always had a third

storey or loft'. 10 The central stack he felt was 'later'. His section drawing is shown in Fig. 21.
