- OBR news
- OBR Presentation Day
- OBR/OAHS lecture
- Themes and debates in vernacular architecture - Part 2
- Forthcoming events

Presentation Day in South Stoke

Themes and debates in vernacular architecture - Part 2

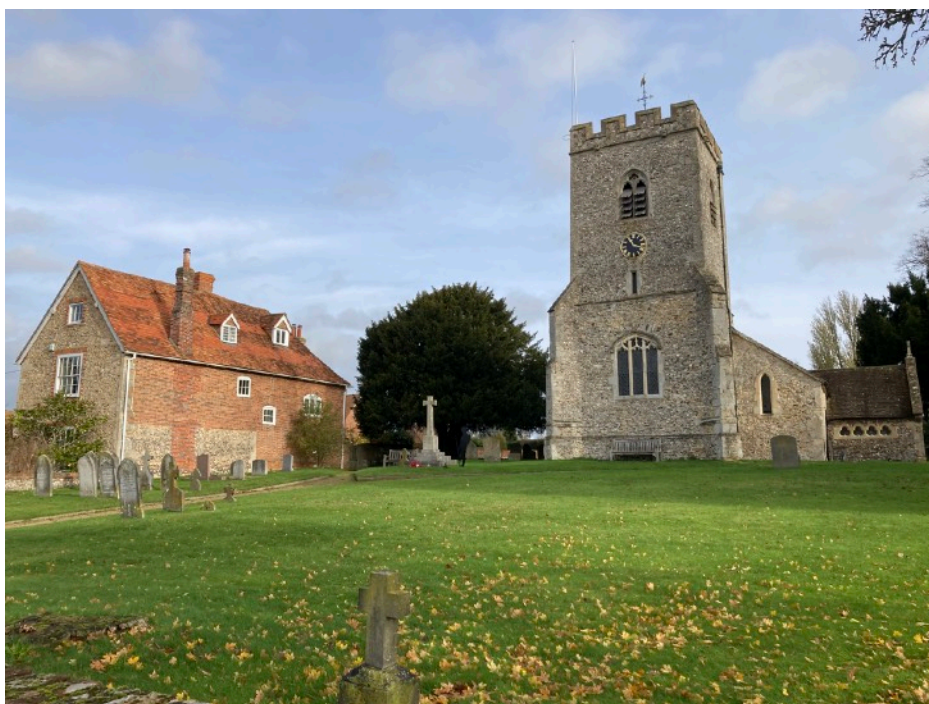
The church is C13 with C14 alterations and mid Victorian restorations made of flint and stone. The former vicarage is a large Victorian house designed by the architect Charles Buckeridge. A non conformist chapel was built in the village in 1820.

The church and east elevation of Manor Farm

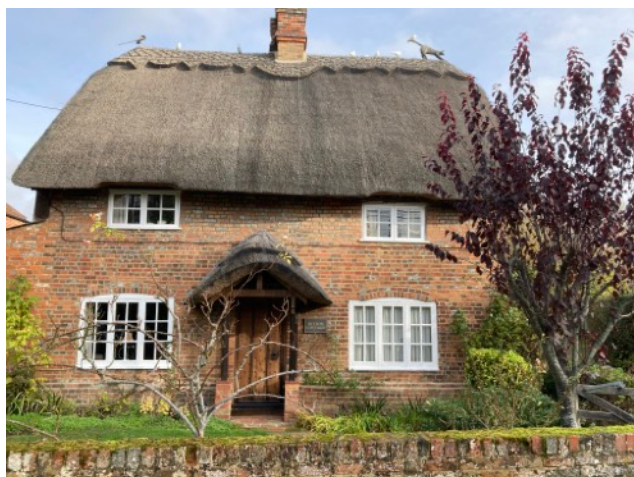
Ditton Cottage

Ditton cottage is a lobby entry layout, its timber frame now hidden by an English bonded brick facing. A joist inside is inscribed with the date 1707. David Clark reported that Smewins Cottage next door is another lobby entry cottage, although its stairs are now in the room alongside the central fireplace rather than in line with the lobby entrance. Its timber framing is pit sawn and has chiselled assembly marks, suggesting late C17 construction. There is a large chimney stack at the east elevation and its two entry doors suggest it might have been later subdivided. A mullion window may indicate an earlier origin, in which case could it have earlier been a detached kitchen for Ditton Cottage?

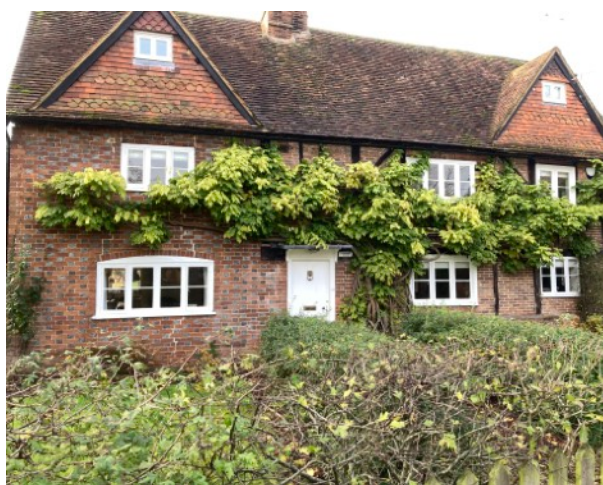
Fulbrook House is another oddity. As built it is a 4 bay early C.17 lobby entry house, but the central 2nd bay housing the chimney stack is much narrower than its neighbouring bays,

and the 4th bay is also somewhat narrower. There is no evidence where the original staircase was sited in the original house. Could there have been a stair tower to the rear? Could the 4th bay have been a detached kitchen (its fireplace is on the other side of the central passage from the main fireplace, and its chimney is independent of the main stack although alongside it above roof level)? Even more speculatively, could the insertion of the 2nd bay indicate a change of mind during building from a medieval hall ground plan to a lobby entry plan form? Another oddity is the north bay roof structure, which most unusually features structurally separate collars on top of truncated principals. This is unlike the other bays, where the collars are tenoned into the principals which extend to the apex of the roof. David thought this was likely to be part of a C18 reconstruction. The south bay exterior has been subsequently clad in Flemish bonded brick, with a date mark of 1820. Rear extensions and alterations were made in the late C20.

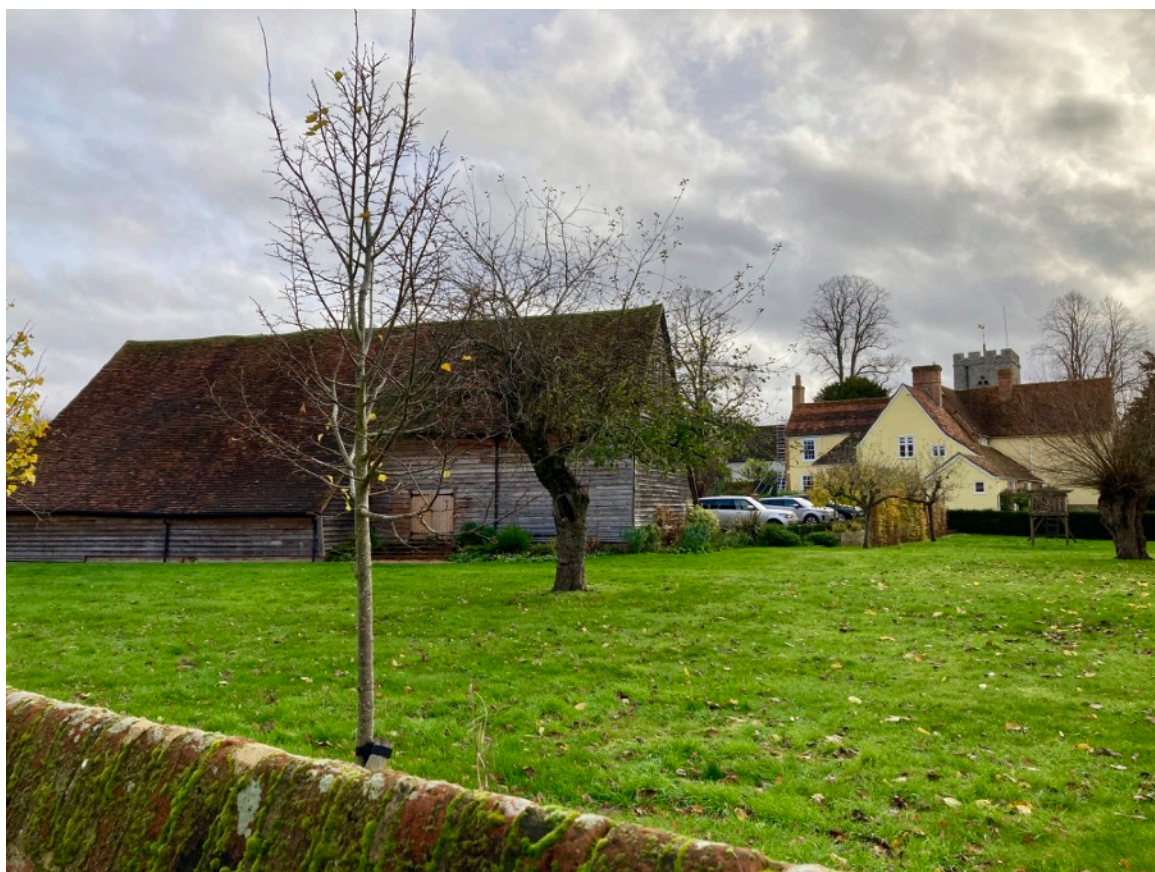
We were only able to see the Manor Farm yard from outside its boundary just off the main street, but it makes an impressive ensemble of very large barn, equally large dovecote and raised granary. One of David Clark's students had counted the number of pigeon hole roosts - 1544.

Manor Farm west elevation and barn

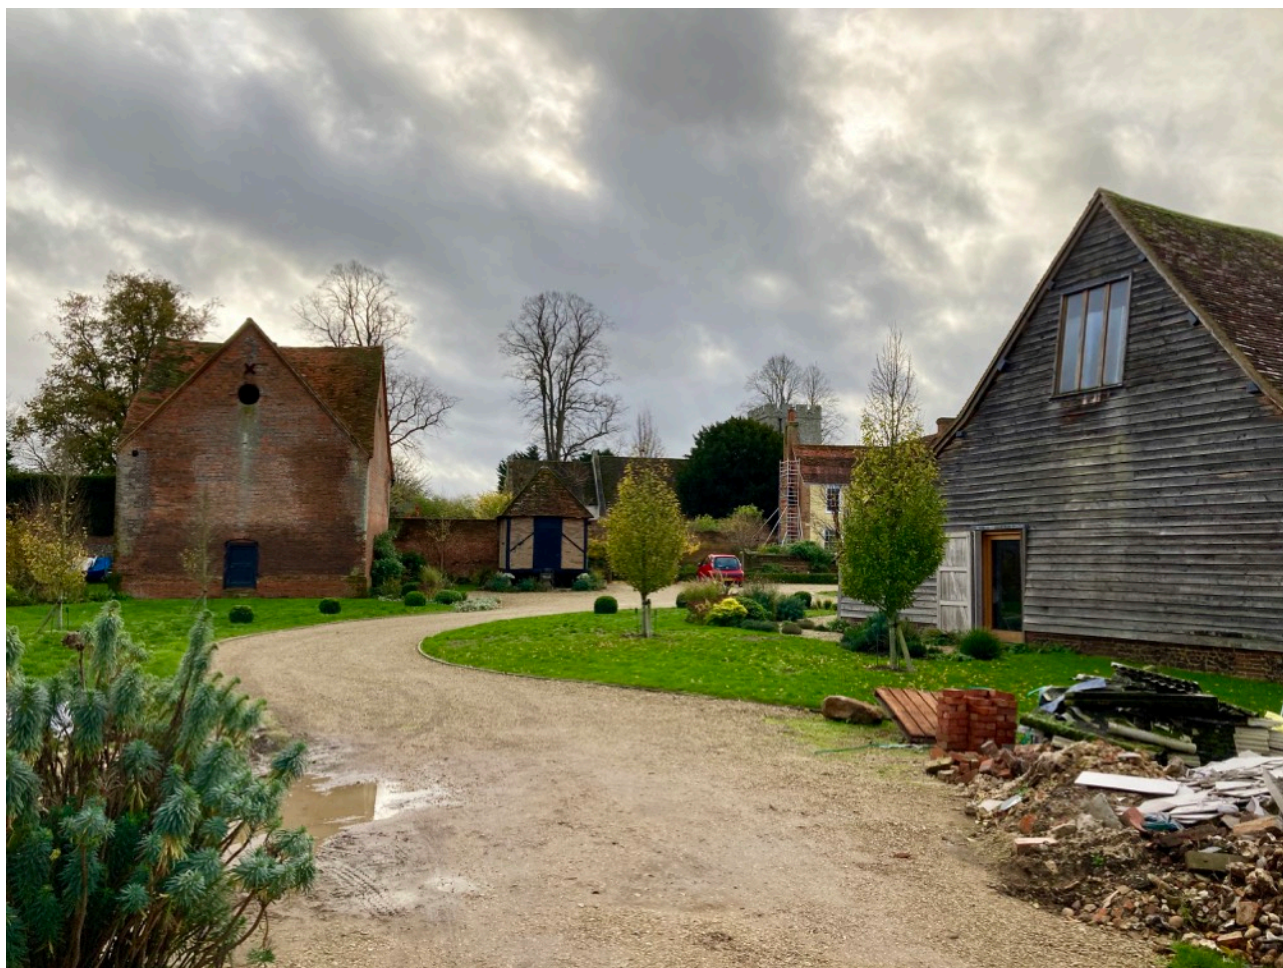
Manors Farm dovecote, granary and barn

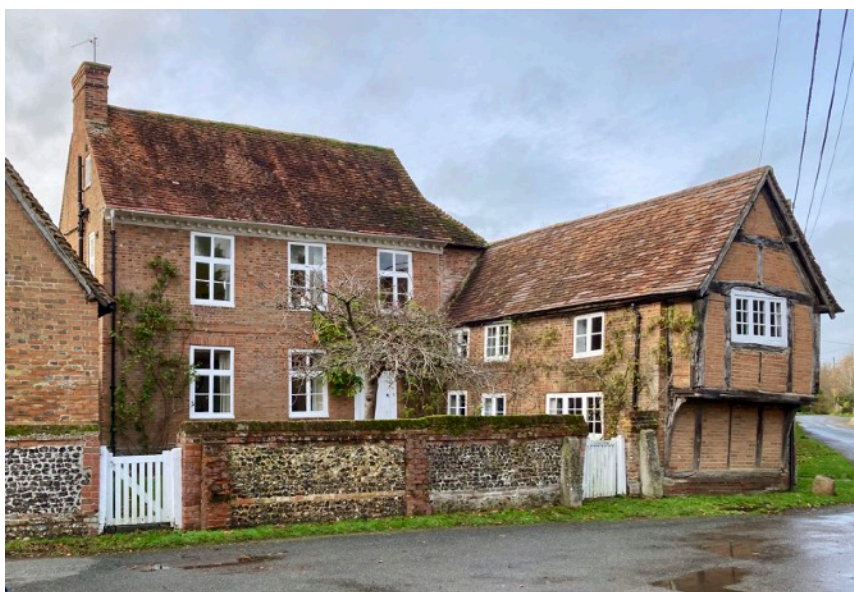
The Corner House is described in its listing description as early C17, with a later C17 main block, but the crown post in the jettied gable suggests a much earlier, probably C15 date. It is timber framed, clad later in brick. The jetty wallplate is moulded on its interior as well as external side.

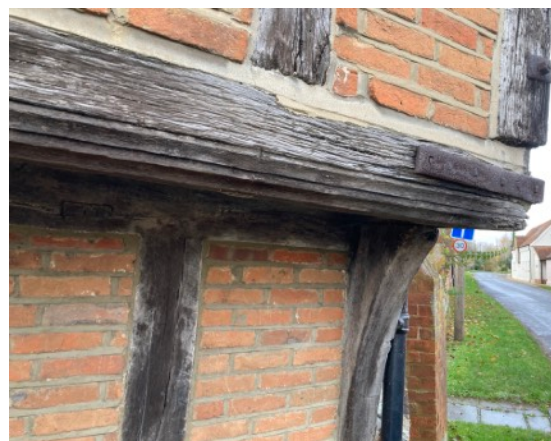
Corner House moulded jetty wallplate

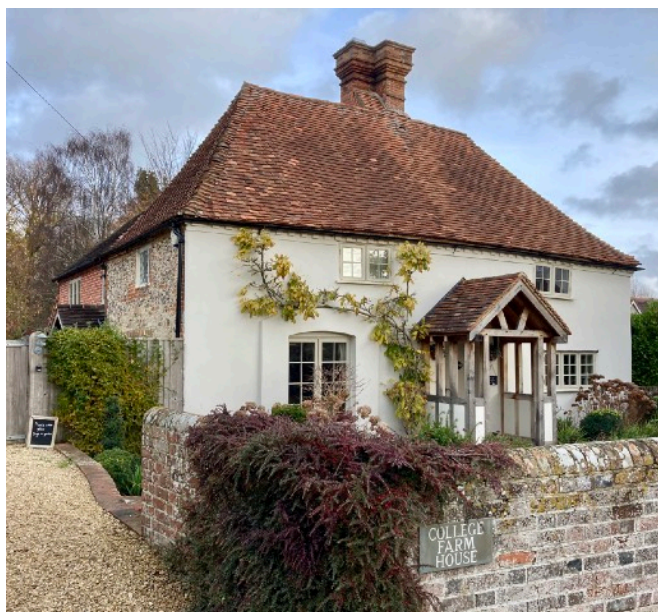
College Farm House

College Farmhouse is another lobby entry probably C17 house, notable for its impressive 3 flue chimney stacks. It is sited on Ferry Lane which runs down to the Thames, where there was a ferry across to Moulsoford provided by the Beetle and Wedge pub - a name that may have referred to this once being the location of an assembly place for timber framing.

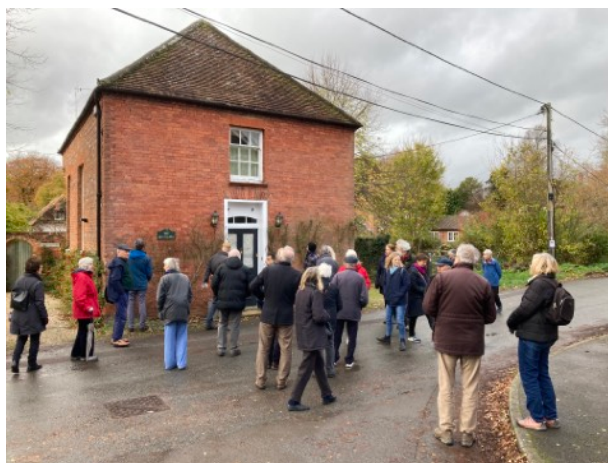
The group inspects the Old Chapel

From there we headed back, past the Old Vicarage, a large house built in 1869 typical of that period, to the Old Chapel, built in the 1820's, one of the evangelical non conformist chapels of the Countess of Huntingdon's Connexion. The end wall is Flemish bond in contrast to the English bond on the side wall - were they were built at different times? One end is cantilevered in order to permit farm carts to access the former farmyard behind the chapel.

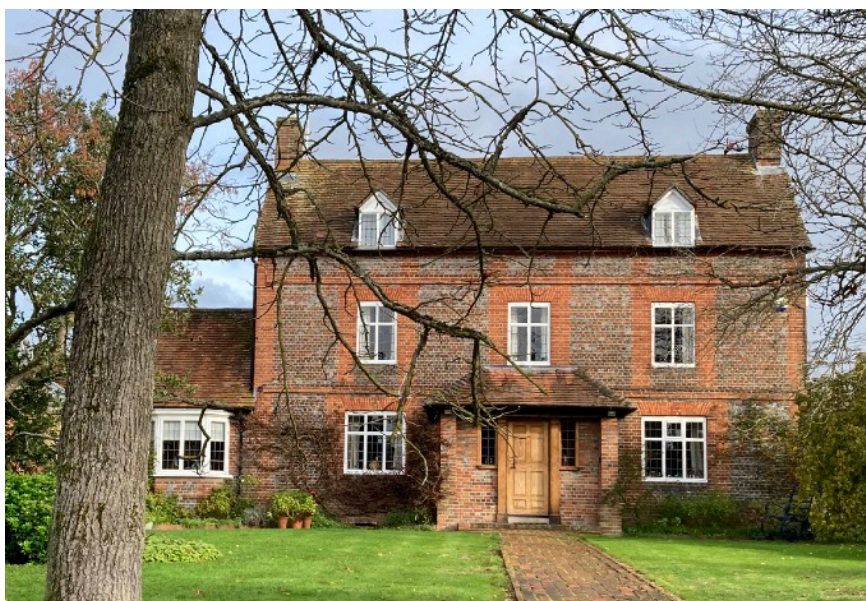
Stoke Abbas House

The tour ended at Stoke Abbas House, late C17 fine brick fronted, featuring typical casement window stays of the period. Then back to the Pike and Perch pub for a generous sandwich lunch.

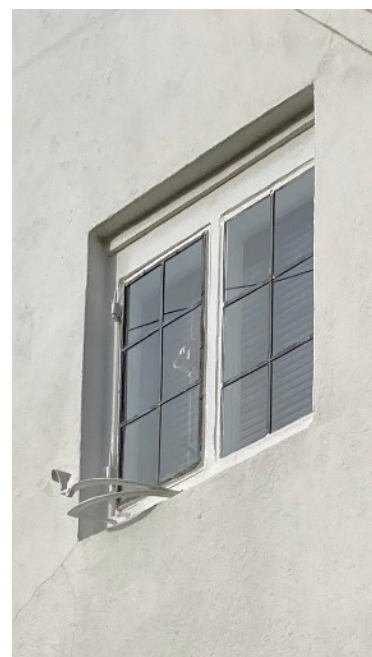
Window stay

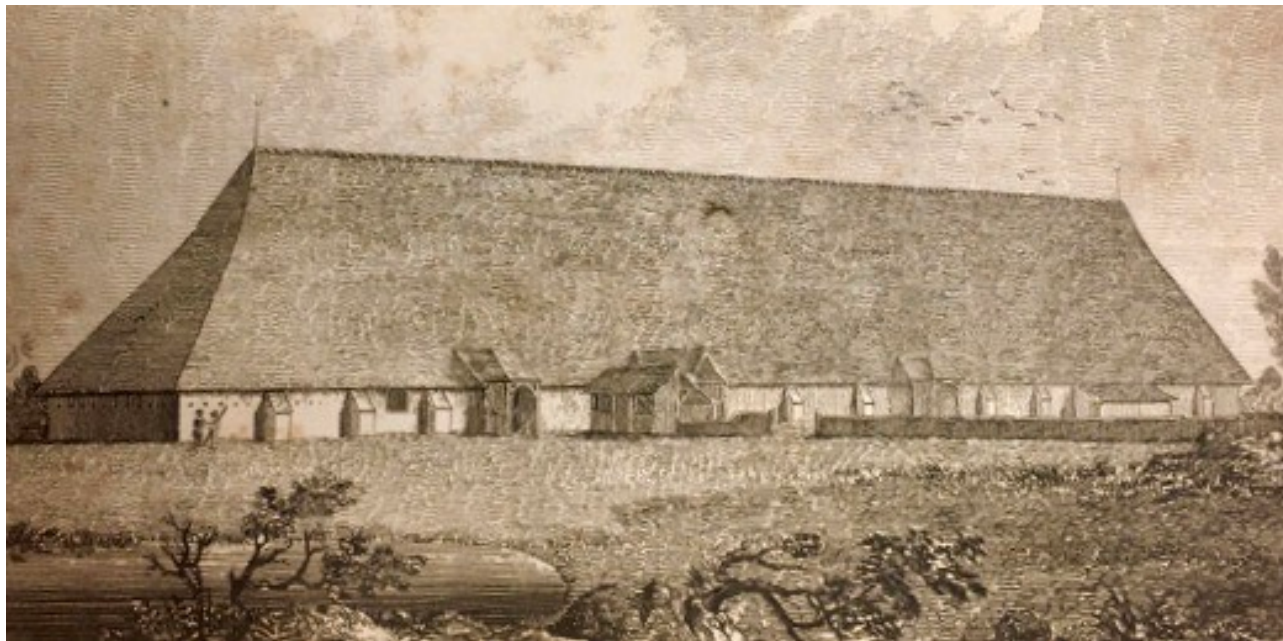
The great barn in Cholsey no longer exists, and Ian's interest is to recreate it virtually. It undoubtedly did exist, as it was surveyed by John Buckler in 1815, and there is a roughly contemporary drawing of it by him. It was demolished soon afterwards due to dilapidation, according to "The Gentleman's Magazine in 1816.

The Great Barn in the early C19

Its dimensions were 303' long x 54' wide x 51' tall. Walter Horn, an American academic, wrote in 1963: "The Barn of Cholsey is unusual in several respects. It is not only the longest medieval barn of England of which there is any record, but it probably is the longest building of its type — whether serving as barn, hall or church — ever constructed in the whole of Europe. Moreover, it holds a unique position among all the great monastic barns of Europe as it is one of only three known structures of this kind to have its roof supported, not by posts of timber, but by two rows of free-standing masonry piers." Some timbers thought to have come from it have been dated as C15.

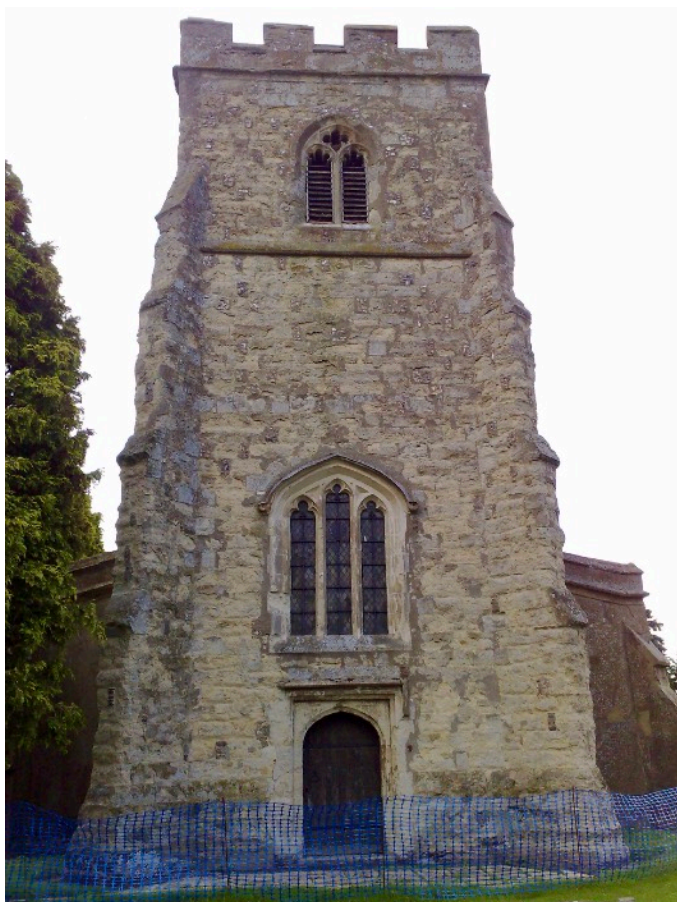
The exterior of this grade 2* predominantly late C13 to early C14 church was heavily restored using Portland cement render in 1902. The render had deteriorated and, being impermeable, water damage was now being sustained by the underlying fabric. Michael, very experienced in lime plaster work including at Cogges in Witney, was the head plasterer for the renovation work.

Slapton church tower before restoration

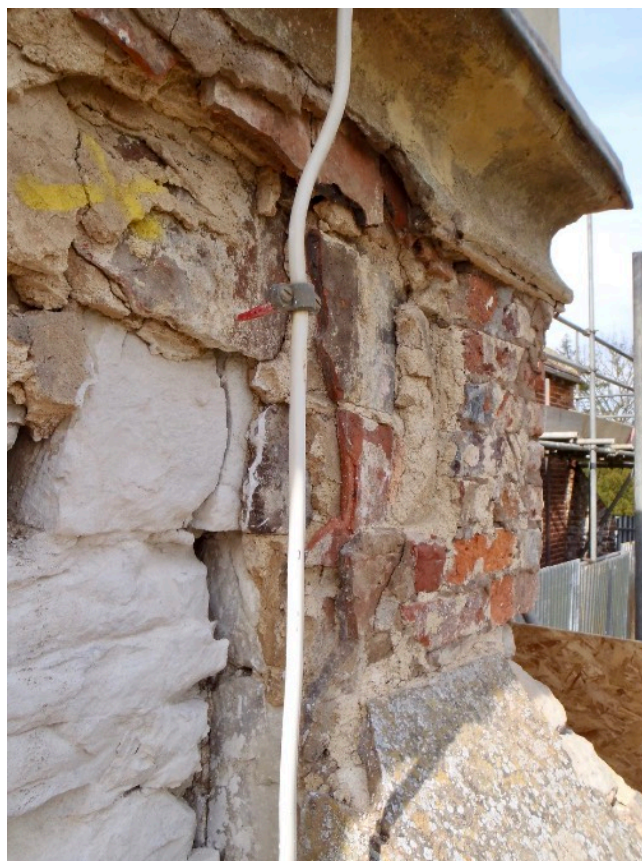
The underlying fabric

Michael described hacking off the concrete render to expose the underlying wall rubble fabric, replacing seriously deteriorated parts with stones and roof tiles set in lime plaster mortar, then applying a shelter coating of light lime plaster prior to 4 or 5 coats of protective lime wash.

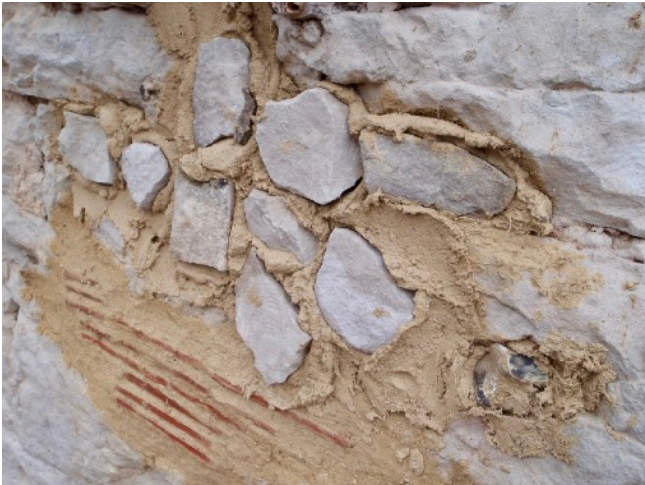
Replacing serious deteriorated parts

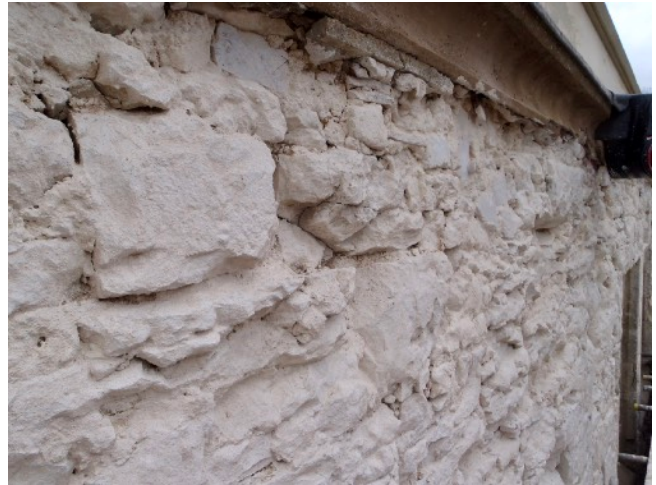
The shelter coating

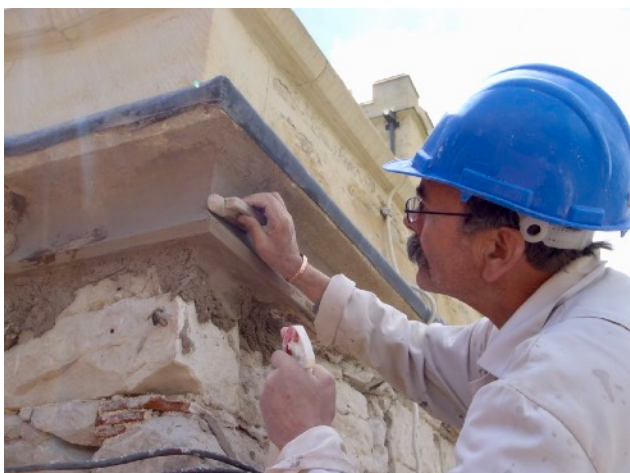
There was also substantial deterioration of cornices and mullions. This was repaired using a natural cement which sets very hard but remains permeable. This cement is also known as Roman cement although there is no connection with cements used by the Romans.

Finishing a cornice

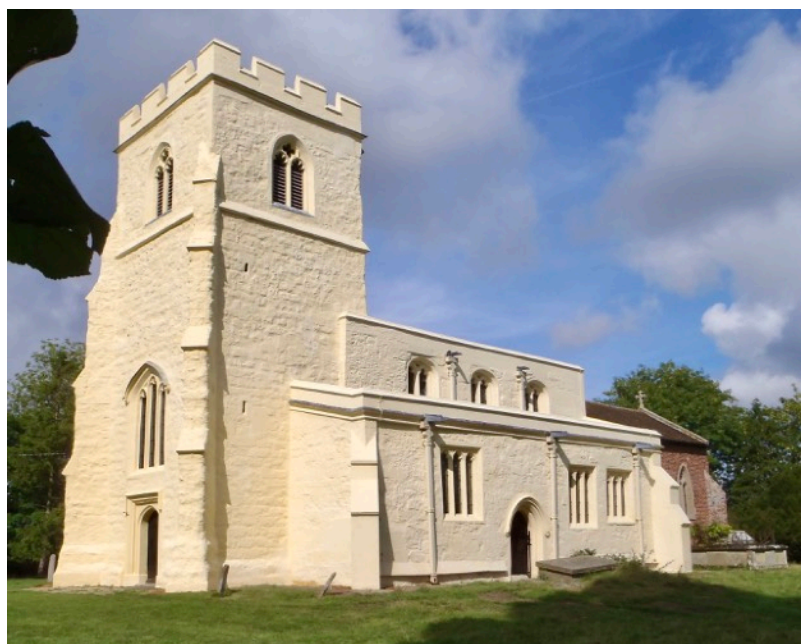
The church restored

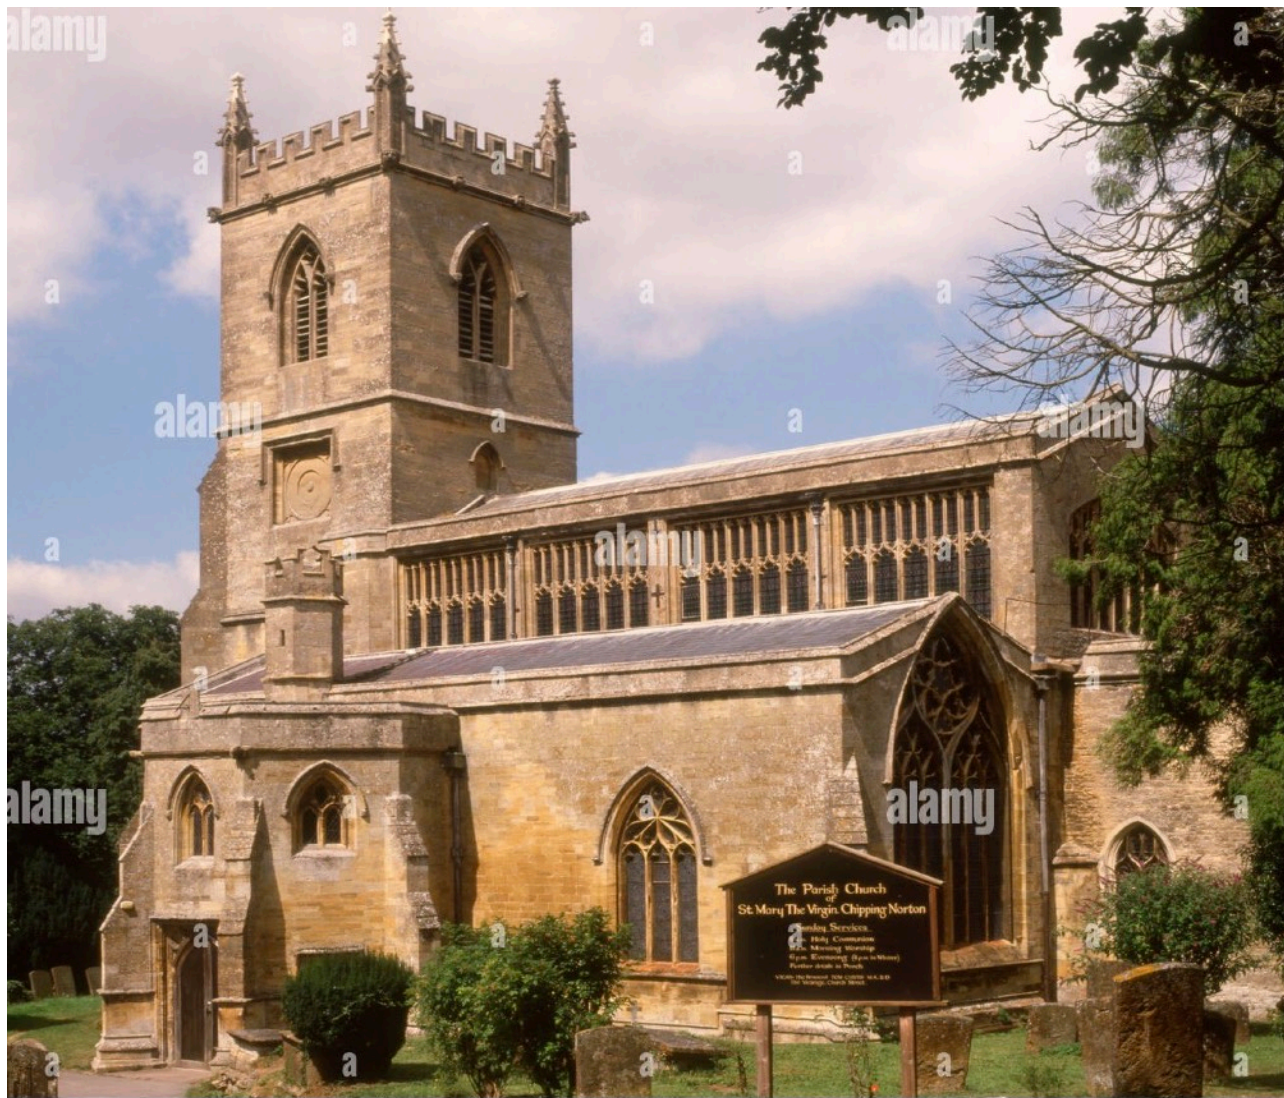
Chipping Norton church. South elevation and hexagonal porch © [alamy.com](https://www.alamy.com)

The church existed by 1096, when it was recorded as given to Gloucester Abbey, but the present building is predominantly C13 to C15, culminating in a major C15 make-over. Its site is unusual in being below the town centre, between town and the castle. The town was planned in the mid C12, while the castle was abandoned in the late C15.

Simon described some interesting features, notably fragments of a former tower arch visible in the internal west wall; evidence of the earlier C13 chancel (probably connected to a new chantry founded in the 1280's) which was subsequently largely remodelled in C15, and the high quality ashlar finish of the C14 south aisle, with its enormous east window the top of which is above roof level. Adjoining the south aisle is a most unusual hexagonal 2 storey entrance porch of the same period. Only two other examples are known, in Bristol and Ludlow.

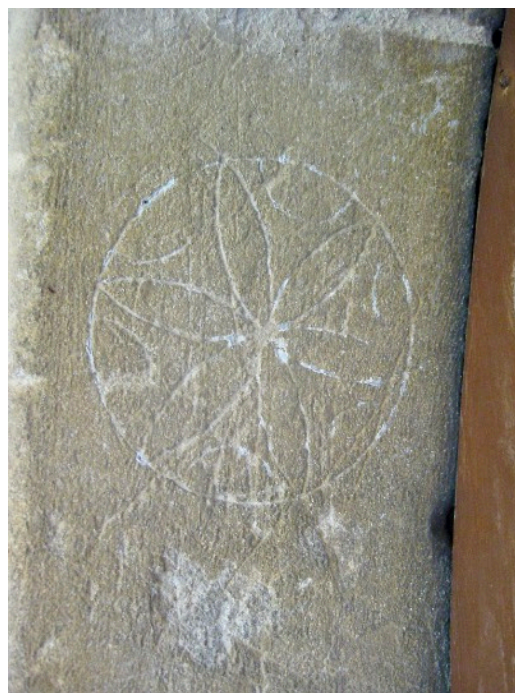
Turning to the double V and circular patterned marks, Owen noted that common apotropaic marks do not feature in past written references to magic or in notes written by magicians, which seems odd. He thought that an equally plausible explanation for the double V was that it represented the signature W standing for William, which was a very popular first name - indeed the most popular one in C19 censuses. People often used symbols instead of full signatures and a stylised W would be a natural symbol for William. Circular marks may simply be doodling, practicing circular patterns.

Hexfoil mark on post - doodling, spiritual or defensive magic?

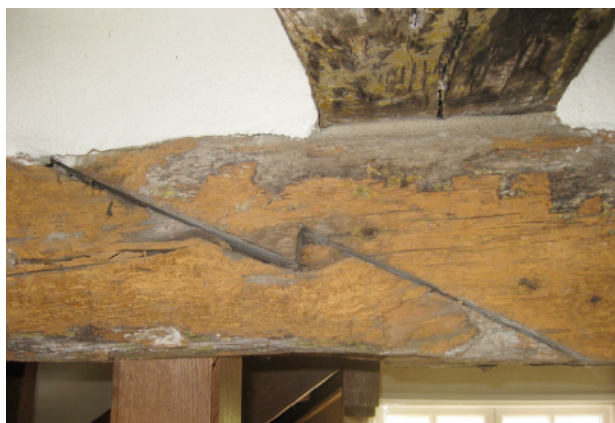
Fig. 2 Splayed-and-tabled scarf joint, 1356 (Steventon)

I'll start with a brief look at how this works in the field of cruck-framed houses (Fig. 1). Two important books on this subject have been published in recent years. The first (in 2013) was *The Medieval Peasant House in Midland England*, which made available the results of a major project focussed on cruck houses, many of which are in Oxfordshire and adjacent counties. 111 houses were recorded, dating from the thirteenth to the sixteenth centuries, and mostly built by peasant farmers – using the term to mean anyone with a small landholding of 30 acres or less (page 106). Underpinning this study was a programme of tree-ring dating, which, while not successful in giving precise dates for all the buildings, allowed carpentry features to be given a chronology that could be applied where accurate dates were unavailable. Thus we can now be more precise about the date ranges for the various different types of scarf joint and can almost read the minds of the carpenters as they tried to find a stronger alternative to the simple splayed scarf which we find in the fourteenth century (Fig. 2).

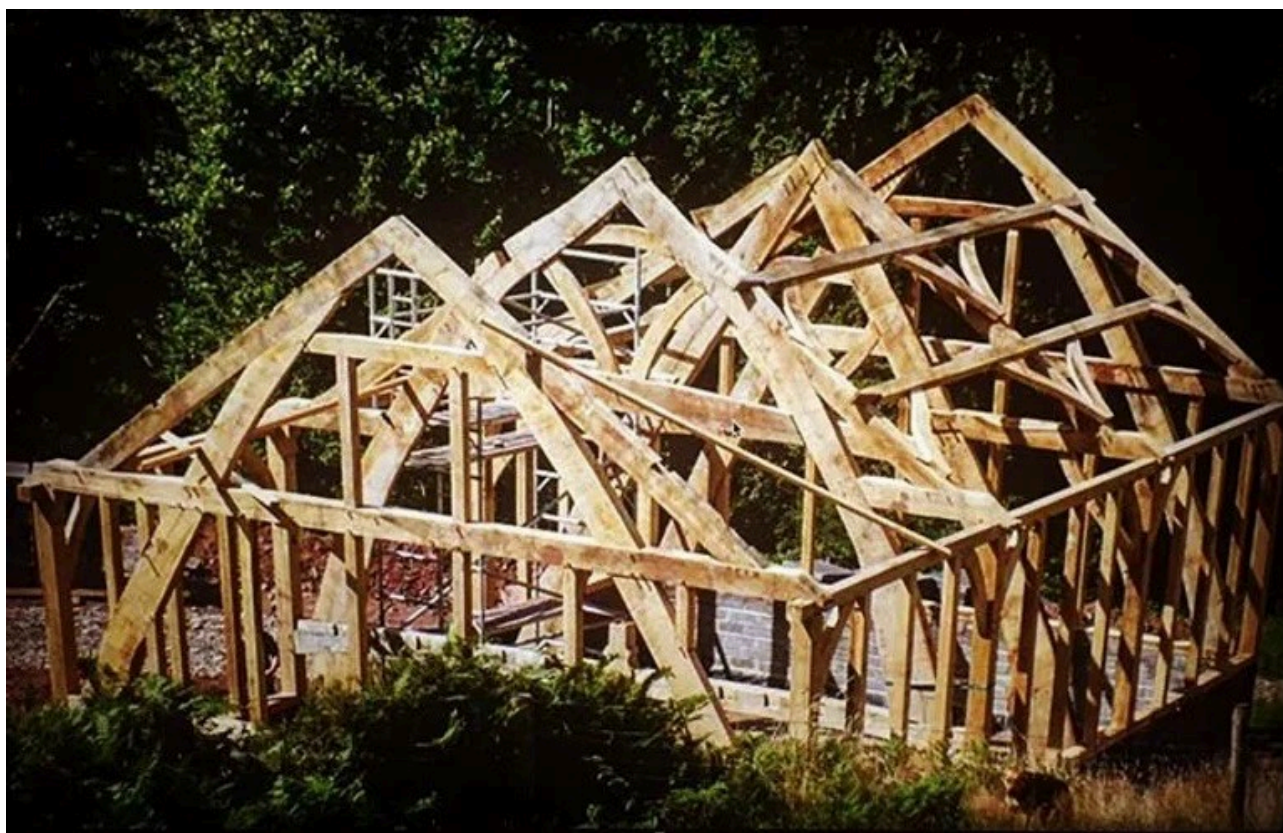
Other cruck features have a geographical distribution, in particular the way in which the cruck blades are joined at the apex, where they invariably support a ridge – in contrast to the box-framed building which usually do not have ridge pieces. There does not seem to be a consensus as to why there is a geographical diversity of these apex types, although once established in an area, their use would have become part of the local carpentry tradition. The later book, *Cruck Building: a Survey* (2019) was based on papers given at a weekend school at Rewley House and built on the considerable corpus of scholarship carried out by members of the Vernacular Architecture Group from its foundation in 1952. This was also largely concerned with carpentry, with detailed papers on a variety of regional traditions. In a somewhat parallel universe, a number of groups also concern themselves with ‘experimental archaeology’ by creating and erecting new cruck buildings in order to demonstrate the techniques involved.

Fig. 3 New Oak Frame Cruck House (© Hewnwood Oak Frame UK)

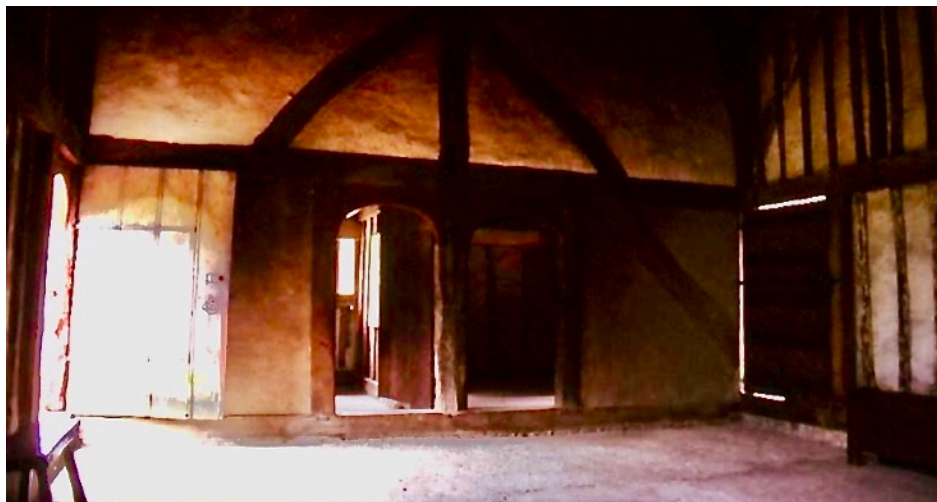
Fig. 4 Buttery and Pantry doors in North Cray House at the Weald and Downland Living Museum

While the questions raised by this – why are there no cruck buildings in East Anglia, can the distribution of apex types be ‘explained’, what is the relationship (if any) between ‘true crucks’ and ‘base crucks’ (which terminate at a tie-beam, and have a different geographical distribution) – are all valid, and the answers worth pursuing, broader issues that we looked at in Part 1 are only now being addressed. The detailed examination of the buildings for *The Medieval Peasant House in Midland England* showed, for example, that in the study area, the cruck houses catered for diverse lifestyles, and such features thought to be universal in the medieval rural house, such as two-bay halls and service doorways, were found to have geographical diversity. So, while most of the Oxfordshire houses had two-bay halls, in the counties to the north, a single bay was the norm. And the paired doorways to buttery and pantry were nowhere to be seen (Fig. 4). The traditional view that small cottages were for

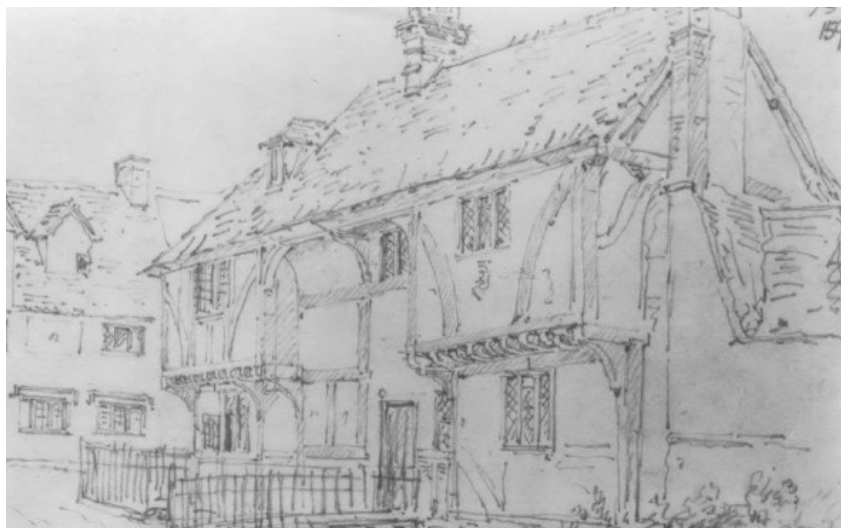
Another area in which attempts are being made to bring the archaeology and the anthropology together is that of the so-called Wealden building type – recognisable by its recessed hall spanned by a braced flying wall-plate. Although in some places the recessed hall has been filled in, this is generally easy to detect. The name comes from the Weald area in Kent and Sussex where there are many (largely rural) examples. And therein lies one of the interesting questions: there is a scatter of other Wealdens in the rest of the country, but these are all in towns, and have gable-end pitched roofs rather than hipped roofs. These buildings date from 1340 to 1525, and the earliest dated examples are in towns. The 1340 building is in Winchester, and other examples can be seen in Lavenham, Wallingford and Stratford-on-Avon; there was one in Oxford (probably in Hollybush Row) which J C Buckler drew in the early nineteenth century (Fig. 5), though it has since been demolished. There is a particularly interesting row of (restored) half-wealdens in Coventry. Did the type originate in urban settings outside the south-east as a stylish form, suitable for shop use and adaptable to form terraces? I am not aware that the documentary sources have yet been fully examined for evidence.

Fig. 5 Old House in St Thomas' Parish, Oxford Augt. 23d 1821 (J C Buckler B.M. Add. M.S 36376 f.159 reproduced in *Oxoniensia* XXXIX (1974))
