OXFORDSHIRE BUILDINGS RECORD REPORT OBR.44

Queens Row, Grove Street, Wantage

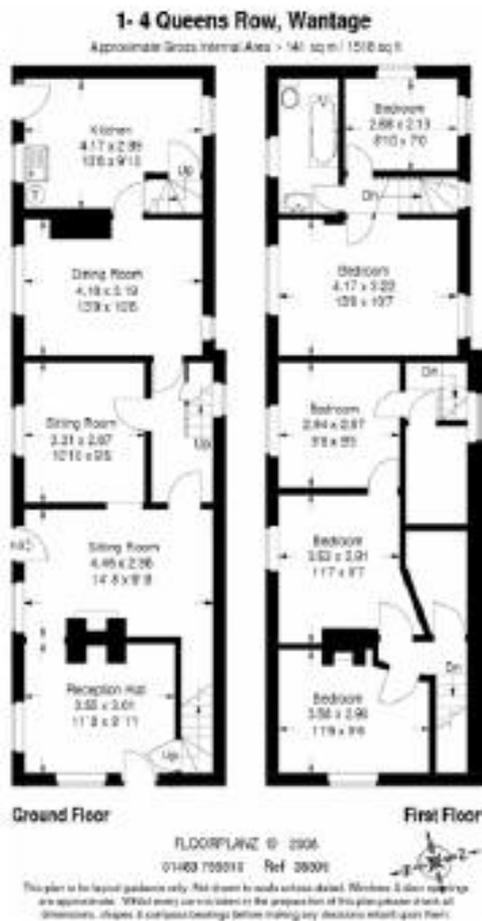
Figure 4 Queens Row floor plans (Right Move)

The Row seems to consist of a larger cottage at the Grove Street end, then three single-bay cottages. See floor plans in figure 4. These have now been connected at ground floor level, but one first floor partition survives.

Beyond these, and now demolished, were four further one-bay cottages, the footings of which can be seen in the yard behind. In addition, there was a wash-house and (presumably) toilets.

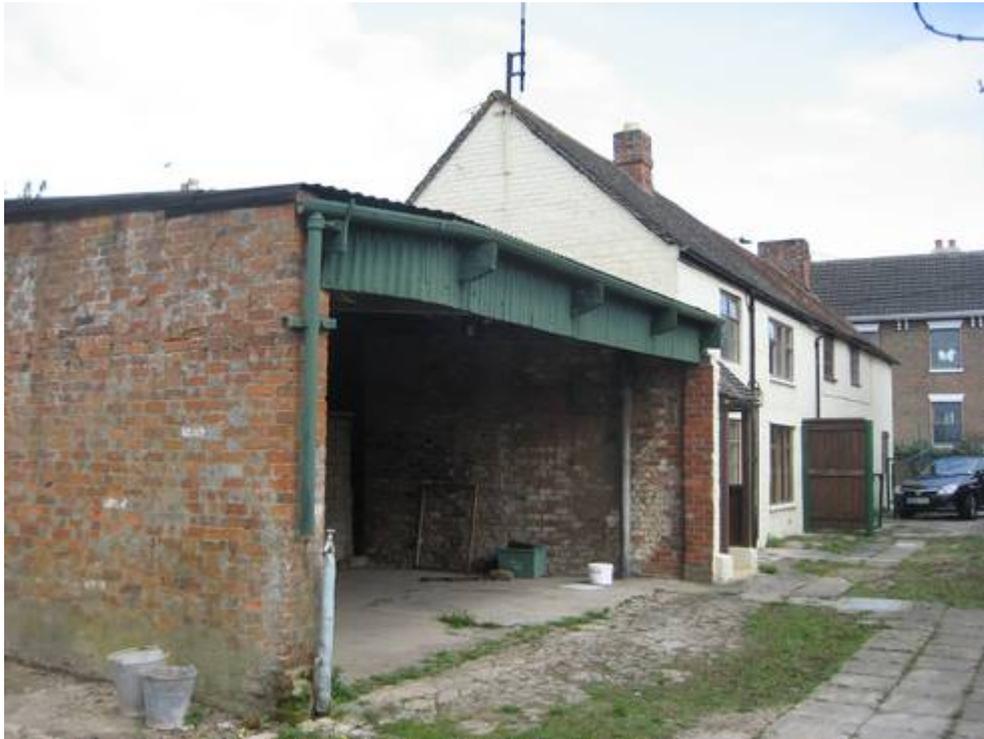
Figure 5 shows where two of the cottages were replaced by an open shed or garage.

Figure 5 Garage in foreground built on foundations of a cottage pair

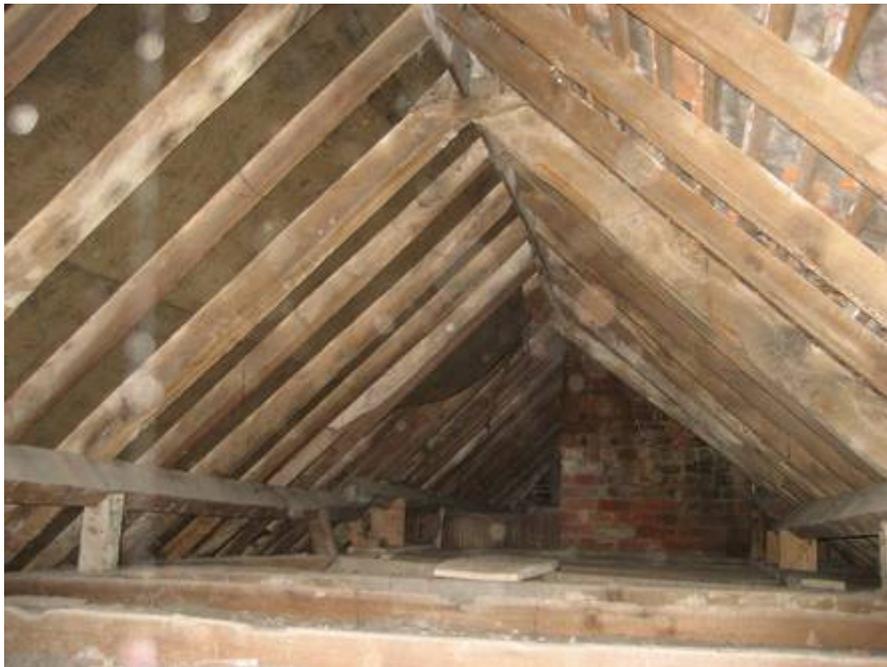
Although there are significant differences in layout and construction (external wall thicknesses vary between the cottages) the internal walls are mostly stud partitions, and there are no party wall gables between the cottages (see figure 6 showing the roof space looking east).

Figure 6 Roof space looking east

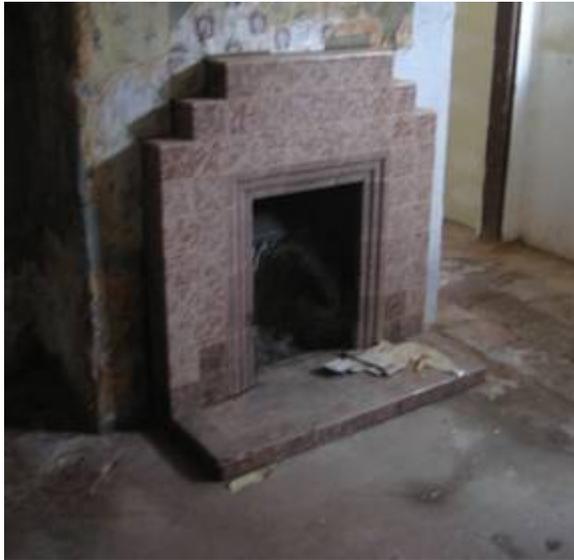
The building history is complex, as many additions and alterations were made by the family of the present owner when it was used as part of a scrap and general dealer's business. Mr Rowles remembers much of this history, such as brick thicknesses, beams put in by his father, alterations to the staircases, the position of former doorways, and the provenance of features such as a 1950s fireplace from Swindon (figure 7).

Figure 7 1950s fireplace from Swindon

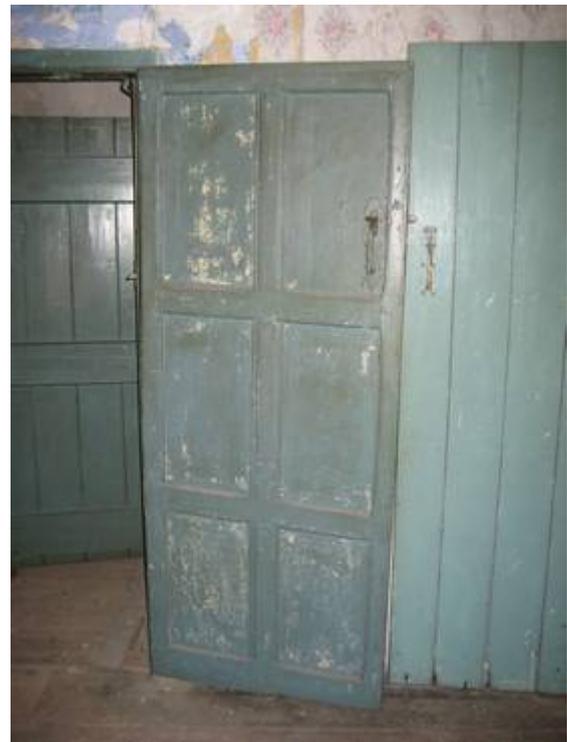
The internal doors are mostly of plain planks with Suffolk latches (no baseplates). One, however, is 17th century, but hung upside down. It has rails with paired pegs and run-out mouldings, small panels, but the dust ledge is at the top of the panel rather than at the foot (figure 8)

Figure 8 Internal doors in central cottage - a plank door on the right, and 17th century panelling on the left - both with Suffolk latches.

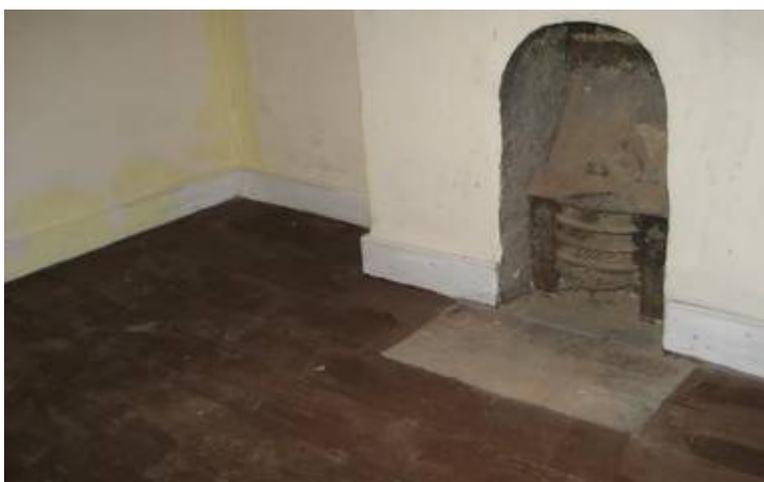
There are two stacks, one between the rooms of the front cottage serving four fireplaces, although only one of these has a grate *in situ* (figure 9). The other stack is between the last two cottages, where there were fireplaces to each of the ground floor rooms. There was also apparently a stack serving the ground and first floor rooms of the central cottage, but this has been removed.

Figure 9 Fireplace in upper front room

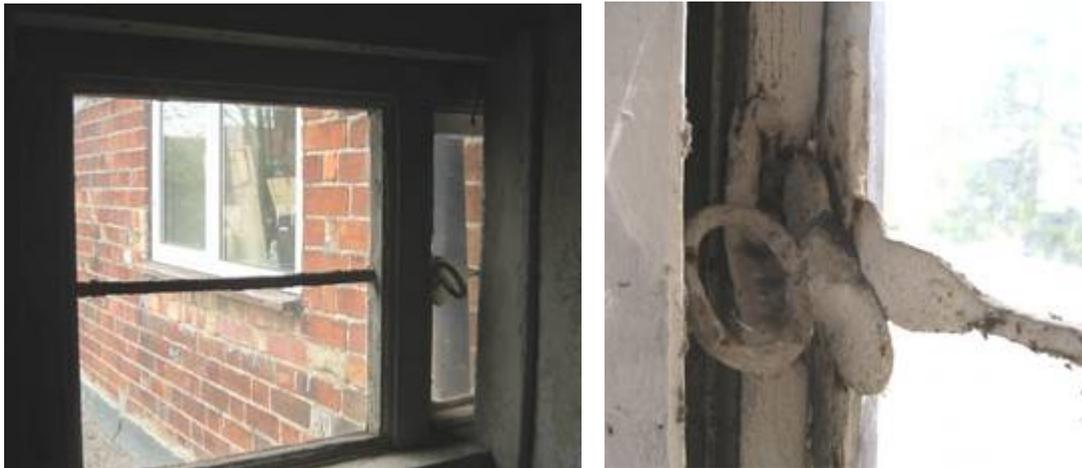
Although most of the fenestration is modern – some even consisting of metal windows laid on their sides – there is one small window to the rear (north) elevation (figure 10) with a turnbuckle catch. Although such catches can be found from the late 16th century onwards, the design is similar to one noted in a house of 1849 in Wiltshire (Hall (2005) p.90). The window itself seems much later, however.

Figure 10 Window in rear wall and turnbuckle catch

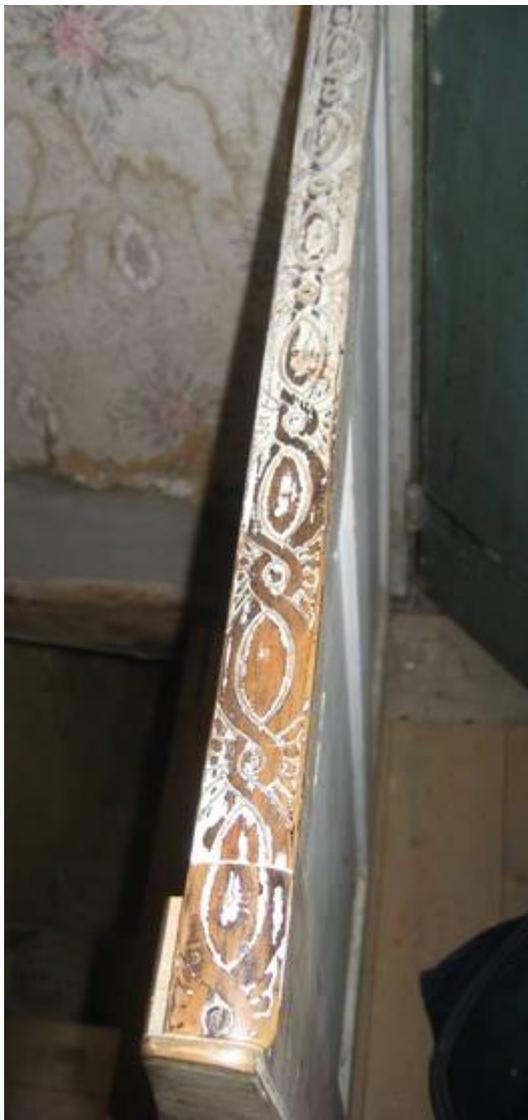
At the top of the central stairs – which had at some point been moved – was an unusual carved rail shown in figure 11.

Figure 11 Carved rail at the top of the central stairway -the stairs are to the left, the landing to the right.

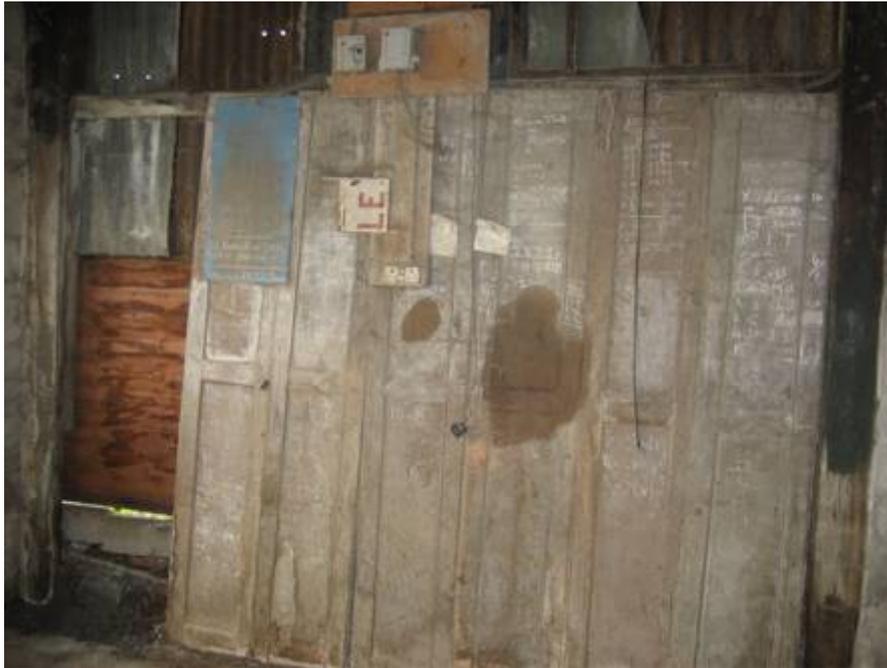
To the rear of the plot is a further garage-type building, now empty, but which at one time covered a manufacturing facility for concrete products. A set of old doors shown in figure 12 still has the prices of various items chalked up.

Figure 12 Doors with concrete item prices
